GROUP Electrical	MODEL 2014MY Forte (YD)
	NUMBER 084	DATE May 2015
TECHNICAL SERVICE BULLETIN		
SUBJECT: SERVICE ACTION: UVO SYSTEM UPGRADE (SA 193)

SUBJECT: SERVICE ACTION: UVO SYSTEM UPGRADE (SA 193)

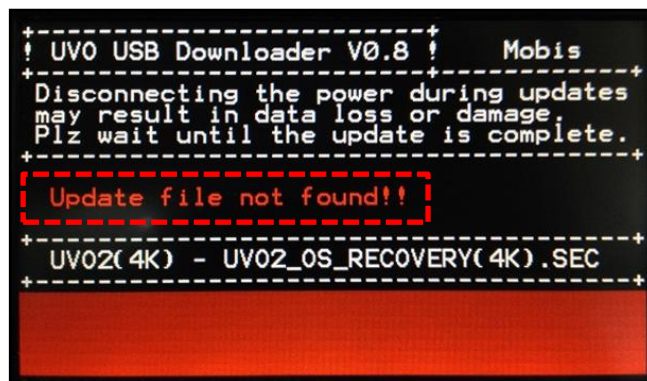
- 10a. If the head unit does not recognize the USB drive, or cannot find the update S/W, the head unit will display "Update file not found!!", as shown. **NOTE: In this case, open a Techline case.**

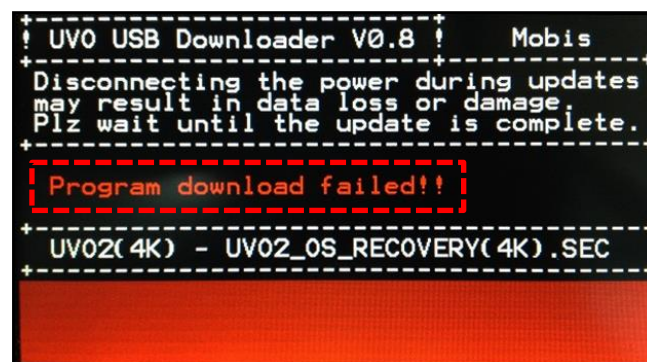
- 10b. If the head unit fails to download the update S/W, the head unit will display "Program download failed", as shown. Press the **RESET** button using a ball point pen and restart the procedure from step 8.
