Service Bulletin

SUBJECT: Special Coverage Adjustment – Cracked Fuel Tank Inlet Control Valve

MODELS: 2006-2008 Chevrolet Cobalt

Subject: 14728A – Special Coverage Adjustment
Cracked Fuel Tank Inlet Control Valve
Revised Part Information Section

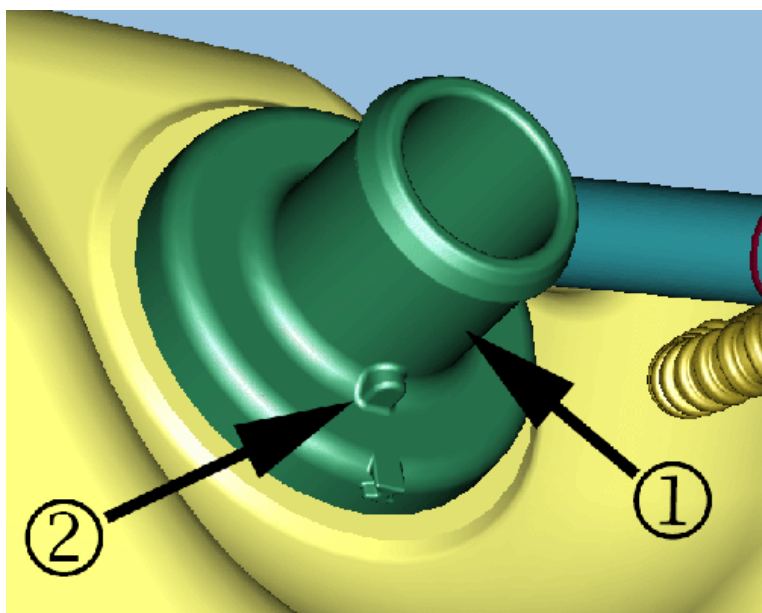
Identifying the 20870462 or 25947828 fuel tank.

The fuel tank hose connection (1) will have an index feature (2) at the bottom 6 o'clock position where the hose joins the tank. Older style tanks have this feature on top at the 12 o'clock position. The fuel tank may also have an identifying tag displaying the part number.

- If the part number is 20870462 or 25947828, and has the bottom index, stop, this bulletin does not apply.

- If the part number *is not* 20870462 or 25947828, and has the top index, proceed to Steps 3 and 4.
3. Replace the fuel tank with p/n 20870462 or 25947828 as applicable. Refer to *Fuel Tank Replacement in SI*.
 4. Replace the filler pipe.
 - a. **Cobalt, G4, G5, Pursuit ONLY:** Use p/n 20757861 fill pipe assembly. Refer to *Filler Tube Replacement in SI*.
 - b. **ION ONLY:** Trim new hose p/n 20757866 to match existing fuel fill hose.
 1. Remove **fuel fill hose** from vehicle mounted fill pipe.
