# Service Bulletin

**SUBJECT:** Service Update for Inventory and Customer Vehicles  
Camera Module Software Update, Steering Column and Battery Checks  
Expires with Base Warranty

**MODELS:** 2015 Cadillac Escalade, Escalade ESV

Subject: 15472 – Service Update Bulletin  
Camera Module Software Update, Steering Column and Battery  
Checks

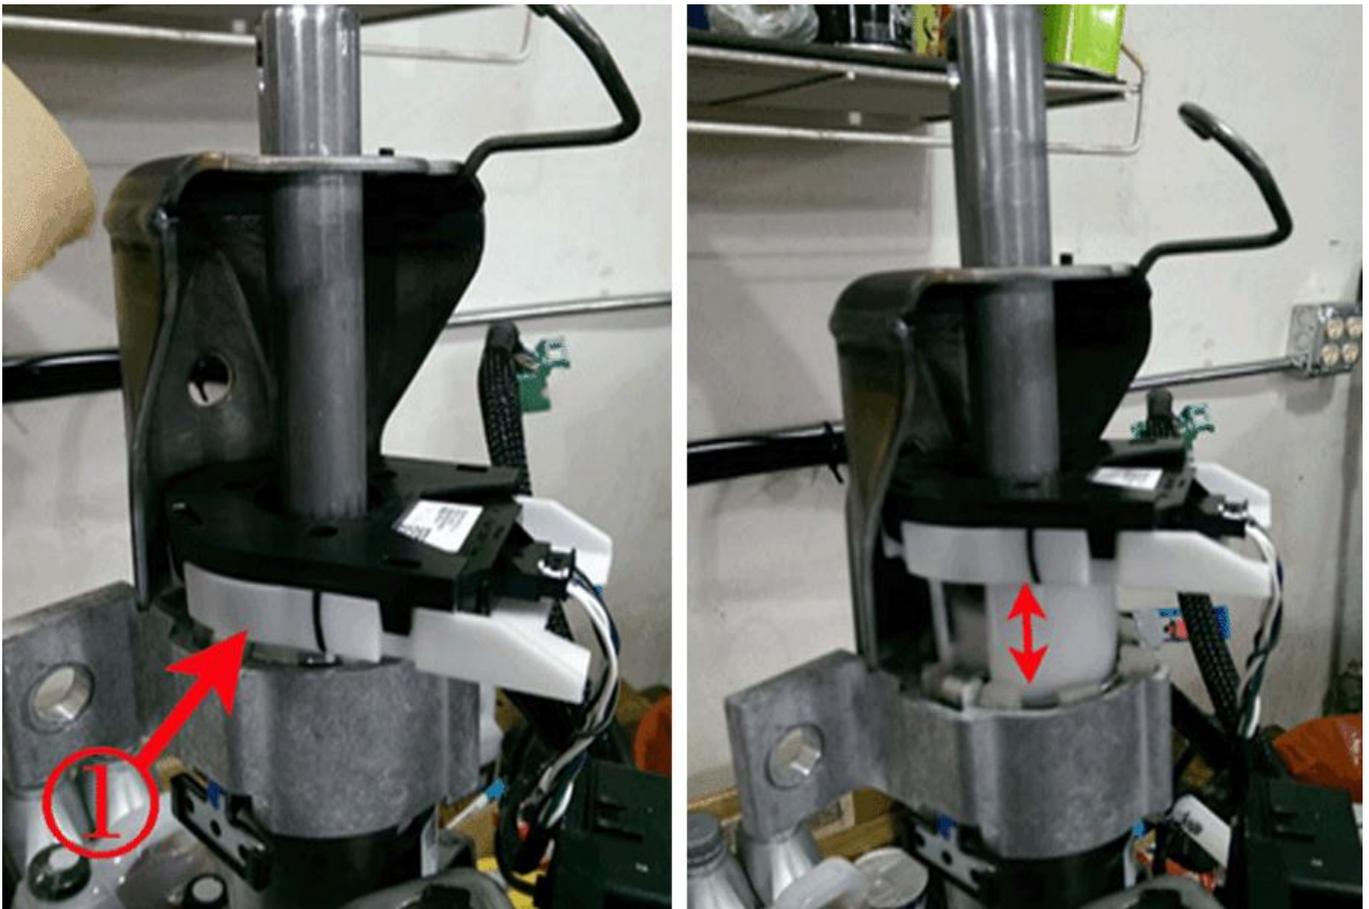
4253196

The lower column bearing housing assembly (1) may be out of position. The 1st picture shows the lower column bearing assembly (1) in its correct position, while the 2nd picture shows the lower column bearing out of position. Steering column is removed for illustration purposes.

**Note:** To correct either above condition, repair the steering column assembly by replacing the column lower bearing adapter assembly and retainer as instructed in the following. Below are the

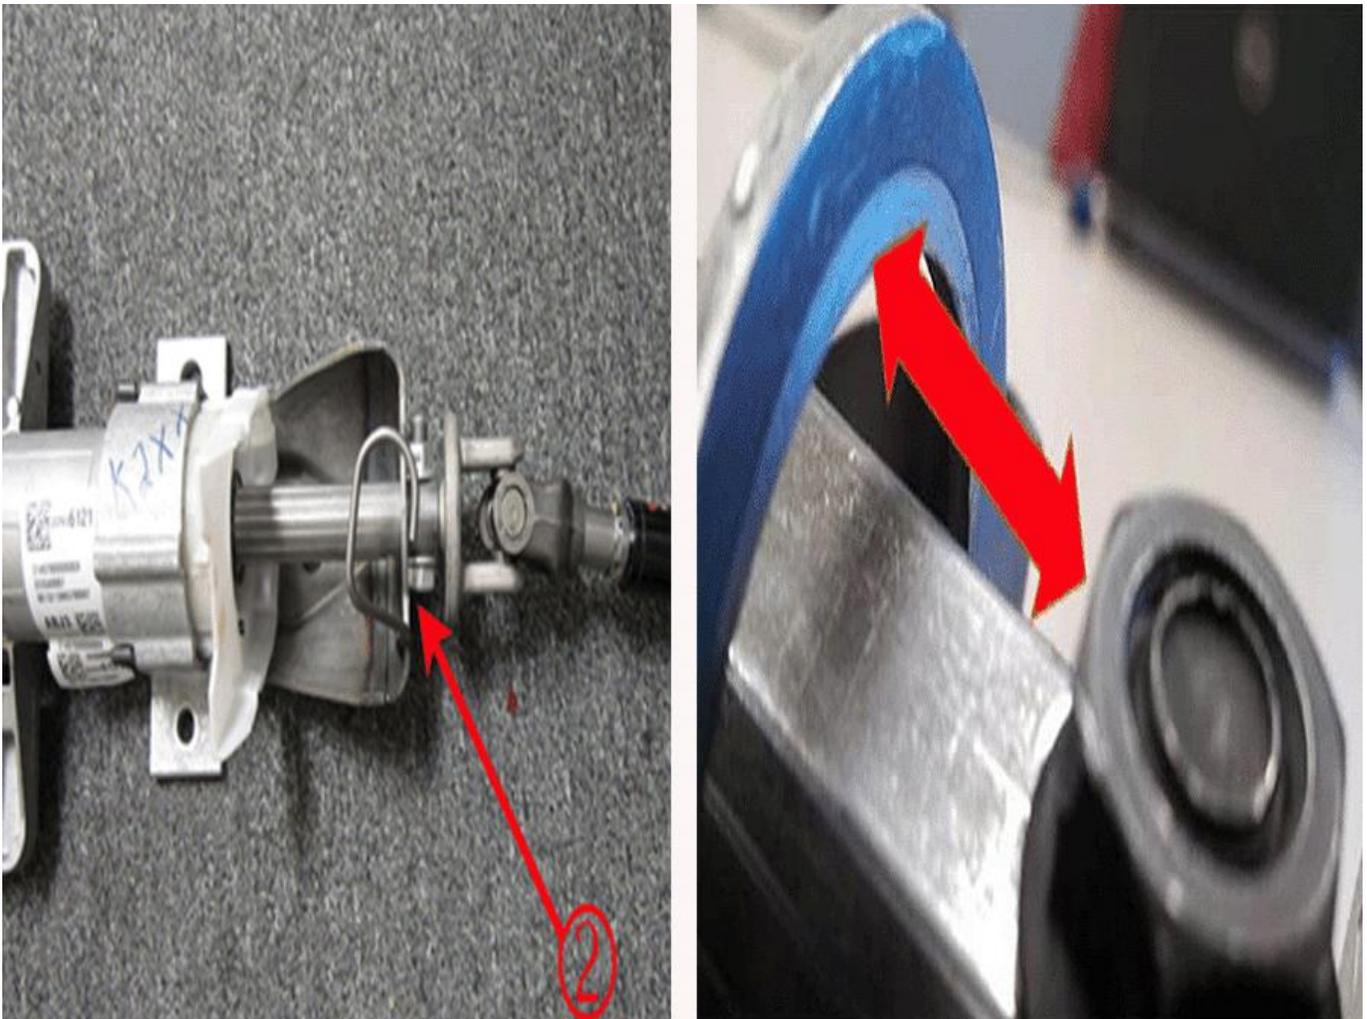
4256119

The upper intermediate steering shaft to lower column shaft bolt and nut (2) may be contacting the inhibitor/shifter cable bracket. Verify there is a minimum 7 mm (0.28 in) gap between the lower column shaft bolt and nut and the inhibitor/shifter cable bracket.
