Service Bulletin

SUBJECT: Special Coverage Adjustment – Side Impact Air Bag Connector Faulty Recall Repairs

MODELS: 2008-2013 Buick Enclave
2008-2013 GMC Acadia
2008-2010 Saturn Outlook
2009-2013 Chevrolet Traverse

Subject: 15536 – Special Coverage Adjustment
Side Impact Air Bag Connector Faulty Recall Repairs

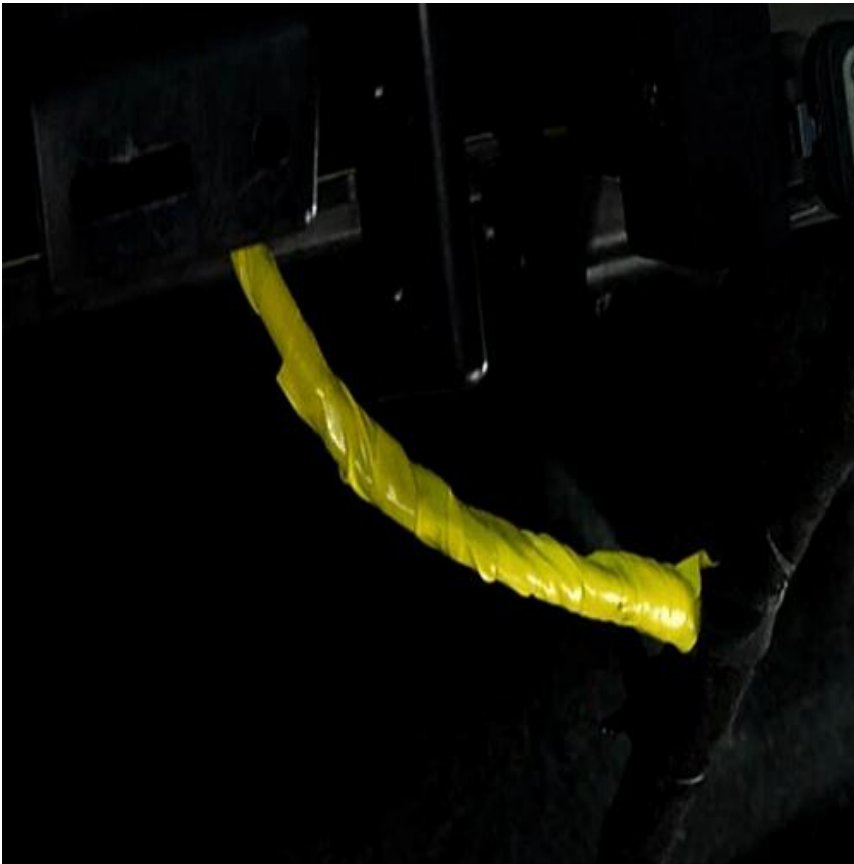
4245693

4. If DTC B0015 or B0022 is set, verify that the appropriate pretensioner connector and CPA are engaged. Proceed with the following wiring repair procedure even if the pretensioner connector or CPA are not fully engaged.

5. Locate the splices in the seat harness which is located near the front bottom of the seat cushion.
