Program Bulletin

CUSTOMER SATISFACTION PROGRAM

SUBJECT: Left Front Knuckle to Hub Attachment Torque

MODELS: 2015-2016 Chevrolet Cruze

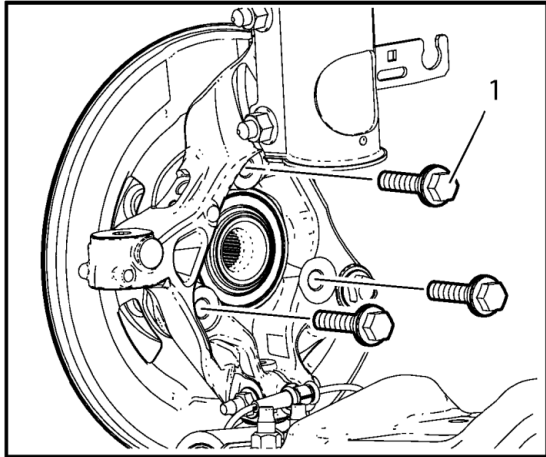
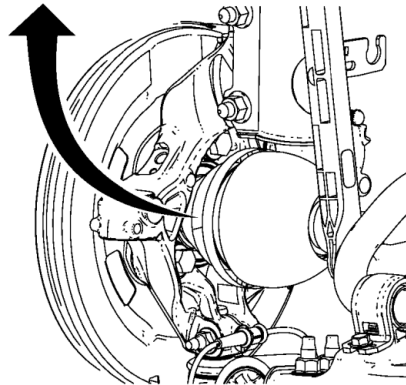
2027764

Certain 2015 and 2016 model year Chevrolet Cruze model vehicles may have been built with the left front knuckle to hub attachment below GM's torque specification. This condition could result in noise from the front suspension and separation of the steering knuckle to hub while driving, resulting in loss of steering control, potentially increasing the risk of a crash.

2. Locate the front driver side bearing/hub bolts.
3. Tighten the bearing/hub bolts (1) in 3 passes. Use the *EN-45059* angle meter. Refer to *Front Wheel Bearing and Hub Replacement* in SI. Ensure to tighten all front driver side wheel bearing/hub bolts.
 - a. First pass to **100 Nm (74 lb ft)**
 - b. Second pass to **20 – 35 degrees**
4. Lower the vehicle. Refer to *Lifting and Jacking the Vehicle* in SI.
