Service Bulletin

SUBJECT: Service Update for Inventory and Customer Vehicles
Main Engine Harness Wire Chafe
Expires with Base Warranty

MODELS: 2016 Cadillac ATS-V

Subject: 15684 – Service Update Bulletin
Main Engine Harness Wire Chafe

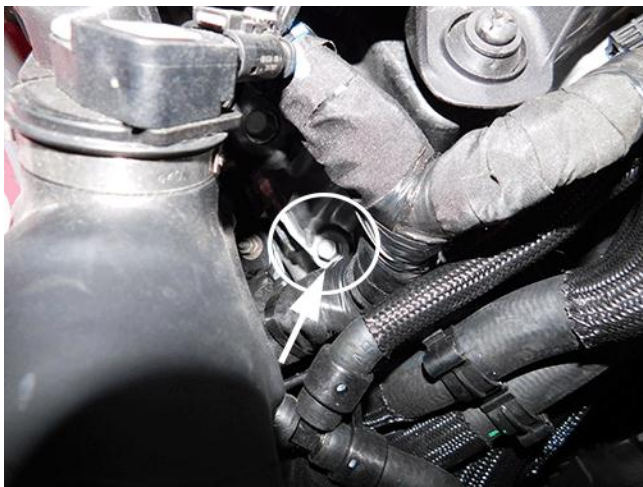
4258399

2. Inspect the engine harness for any rub through and/or chafing from the cam cover bolt by loosening the right intake snorkel clamp and moving the snorkel out of the way. If any damage to the engine harness is found, refer to SI for wire repair.

Note: There should be no contact between the cam cover bolt and the harness.

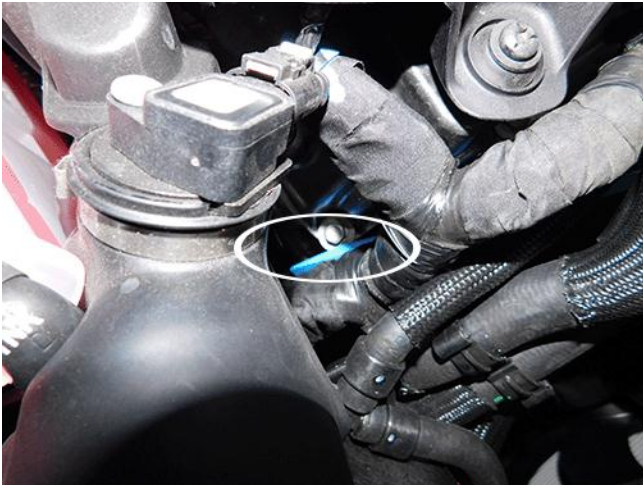
4258401

3. Using a nylon trim tool or equivalent, insert the tool between the engine wiring harness and cam cover bolt and make sure there is a 5 mm (3/16 inch) space in between.
 - If there is enough space, inspection is complete and no further action required.
 - If there is not 5 mm (3/16 inch) of space between the harness and the cam cover bolt, continue to step 4.
