Service Bulletin

SUBJECT: Special Coverage Adjustment – Fuel Odor or Spotting on Ground – Replace Fuel Pump Module

Date: July 8, 2015

Subject: 12191B – Special Coverage
Fuel Odor or Spotting on Ground – Replace Fuel Pump Module
Revised Part Information, Service Procedure, and Warranty
Transaction Information Sections

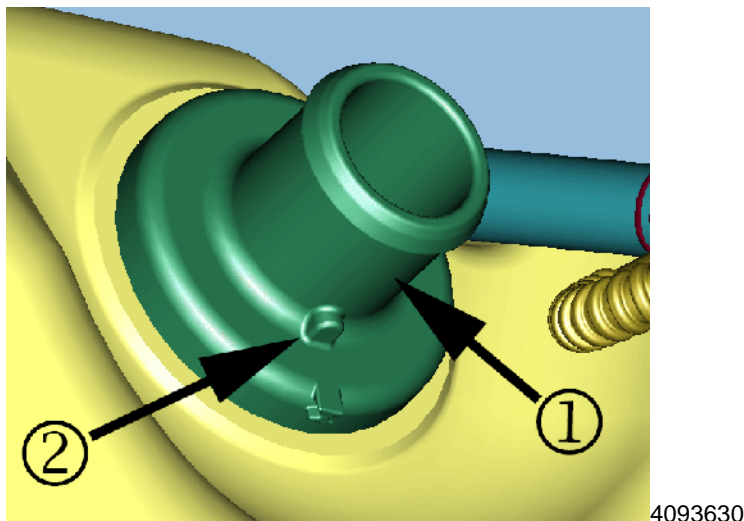
Identifying the 20870462 or 25947828 fuel tank.

The fuel tank hose connection (1) will have an index feature (2) at the bottom 6 O'clock position where the hose joins the tank. Older style tanks have this feature on top at the 12 O'clock location. The fuel tank may also have an identifying tag displaying the part number.

- If the part number *is* 20870462 or 25947828, and has the bottom index, **do not** replace the fuel tank or fill pipe.
3. If the part number *is not* 20870462 or 25947828, and has the top index, **replace the fuel tank and fill pipe or fill hose as applicable**. **For 2006-2008 Chevrolet Cobalt, Pontiac Pursuit, G5:** Remove the fuel tank filler pipe. Refer to *Fuel Tank Filler Pipe Replacement* in SI.
