Bulletin No.: 14665  
Date: July 2015

## CUSTOMER SATISFACTION PROGRAM

**SUBJECT:** Brake and Fuel Pipe Bracket Contacting Fuel Feed Pipe

**MODELS:** 2014 Chevrolet Caprice Police Patrol Vehicle (PPV)  
Equipped with 3.6L Engine (RPO LFX)

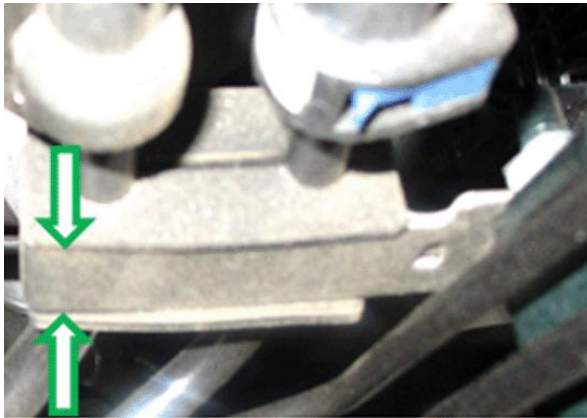
Bracket centered on rubber isolator.

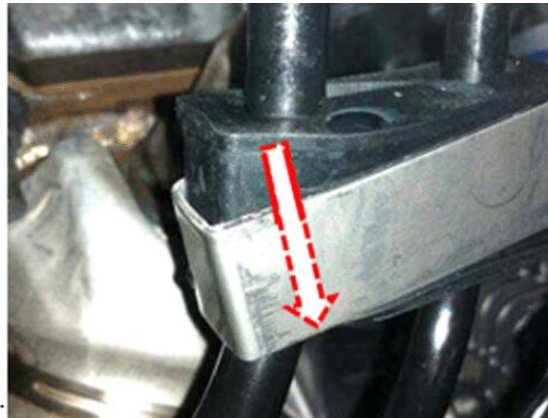
4225066

Bracket out of position.

3. Inspect the fuel feed line bracket to ensure the alloy metal sleeve is located correctly between the flanges of the rubber isolator.

- If the bracket is located in the **OK** position as shown on the left, no further action is required
- If the bracket alignment is found to be **NOT OK** as shown on the right, unfasten the bracket retaining nut and rotate the bracket to the **correct** position as shown on the left. Retorque the retaining nut to **22 N•m (16 lb-ft)**, and proceed to *Inspecting the Fuel Feed Line for Damage*, in this bulletin.

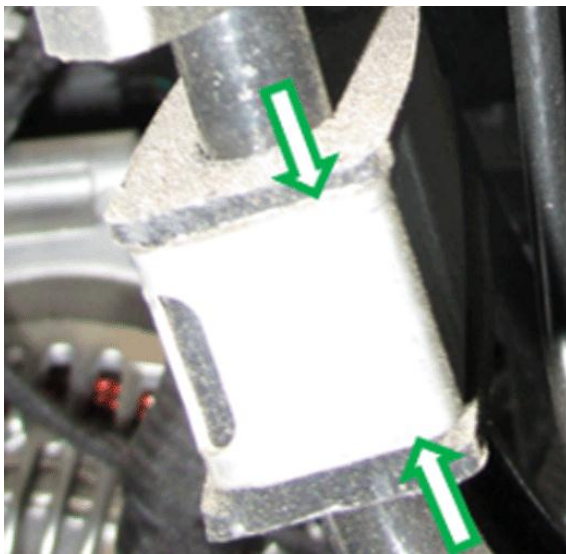
Bracket centered on rubber isolator.

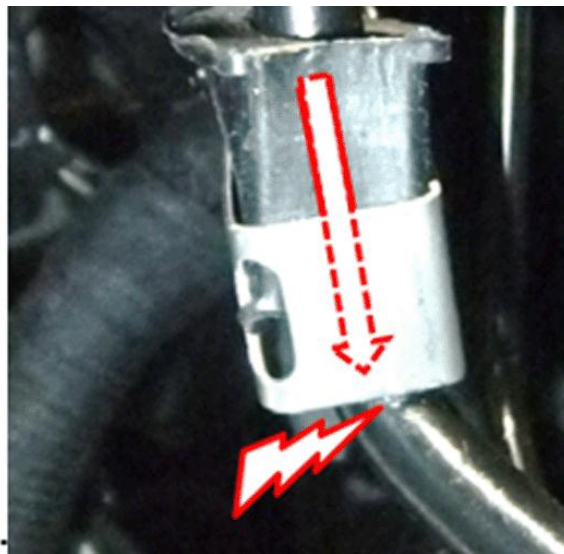
4225072

Bracket out of position.

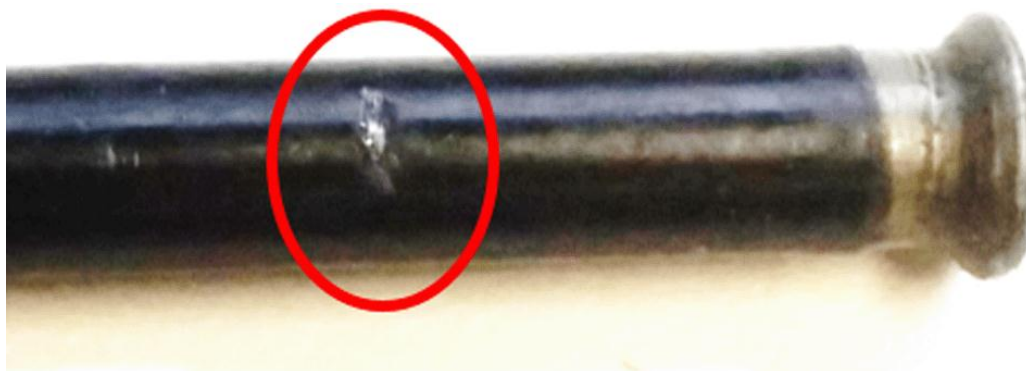
4225075

The fuel feed line consists of a mild steel inner line that is protected with a PVC coating. This coating may be damaged due to contact with the retainer bracket.

- Inspect the steel inner fuel line for any wear marks in the PVC coating where the bracket has contacted the line. There **MUST NOT BE ANY RUB THROUGH CONDITION** exposing the steel line as shown. **If the inner steel line is exposed, the fuel feed line MUST BE REPLACED.**
- If the PVC coating is still intact, and the inner steel line is not visible at the contact area, no further action is required.
