Service Bulletin

SUBJECT: Special Coverage Adjustment – Cracked Fuel Tank Inlet Control Valve

**MODELS: 2006-2008 Chevrolet Cobalt
2006 Pontiac Pursuit, G4
2007-2008 Pontiac G5
2006-2007 Saturn ION**

Subject: 14728 – Special Coverage Adjustment
Cracked Fuel Tank Inlet Control Valve

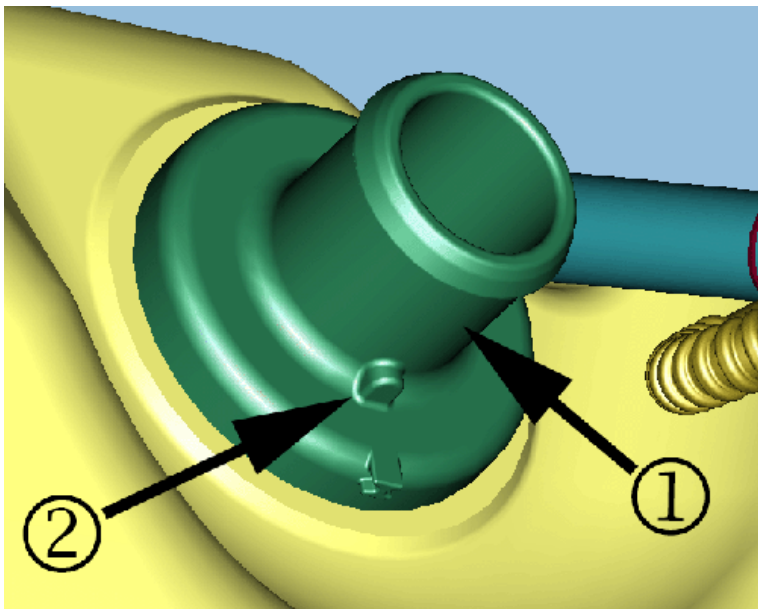
**Identifying the 20870462 or 25947828 fuel tank.**

The fuel tank hose connection (1) will have an index feature (2) at the bottom 6 o'clock position where the hose joins the tank. Older style tanks have this feature on top at the 12 o'clock position. The fuel tank may also have an identifying tag displaying the part number.

- If the part number is 20870462 or 25947828, and has the bottom index, stop, this bulletin does not apply.

- If the part number *is not* 20870462 or 25947828, and has the top index, proceed to Steps 3 and 4.
3. Replace the fuel tank with p/n 20870462 or 25947828 as applicable. Refer to *Fuel Tank Replacement in SI*.
 4. Replace the filler pipe.
 - a. **Cobalt, G4, G5, Pursuit ONLY:** Use p/n 20757861 fill pipe assembly. Refer to *Filler Tube Replacement in SI*.
 - b. **ION ONLY:** Trim new hose p/n 20757866 to match existing fuel fill hose.
 1. Remove **fuel fill hose** from vehicle mounted fill pipe.
