Service Bulletin

SUBJECT: Special Coverage Adjustment – Coolant Leak / Drip on Automatic Transmission Shifter Grommet

MODELS: 2011-2012 Chevrolet Cruze
Equipped with 1.8L (LUW) Engine and 6-Speed Automatic Transmission (MH8)

Subject: 14773 – Special Coverage Adjustment
Coolant Leak / Drip on Automatic Transmission
Shifter Grommet

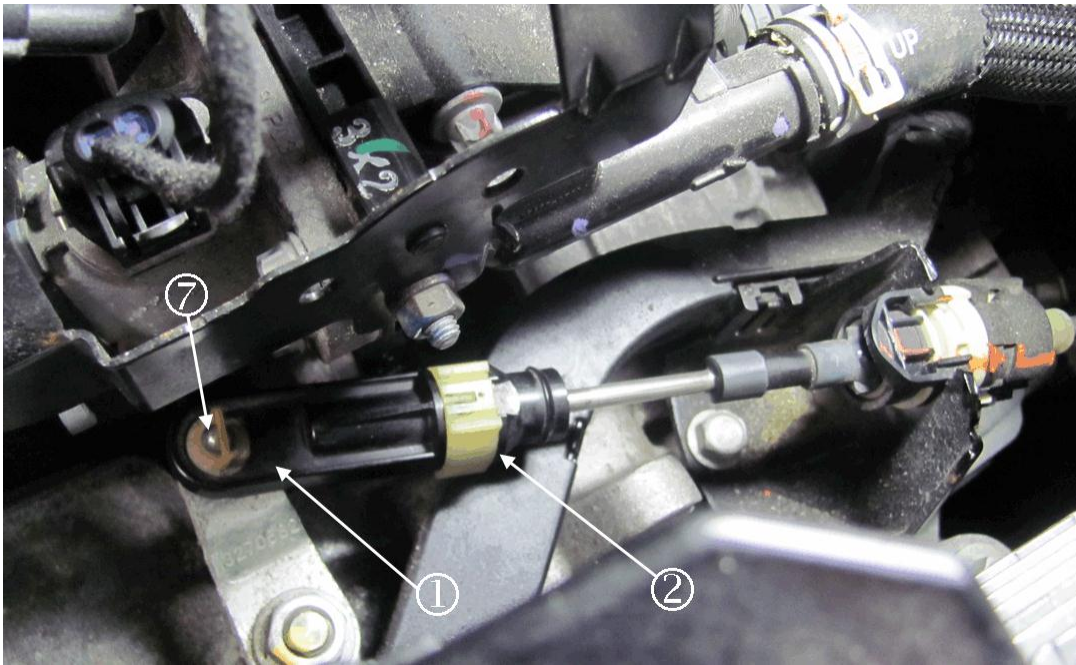
4211012

Photograph shown with the secondary lock and outside spring removed to show the white lock clip fully engaged. The top of the white lock clip should be flush with the black adjuster body.

9. Install the front end of the adjuster body (1) onto the transmission shift lever ball stud (7).
