GM Bulletin No.: 14856  
Date: July 2015

# Service Bulletin

**SUBJECT:** Service Update for Inventory and Customer Vehicles  
Contact Between Electrical Harness and Brake Line  
Expires with Base Warranty

**MODELS:** 2015 Chevrolet Colorado  
2015 GMC Canyon

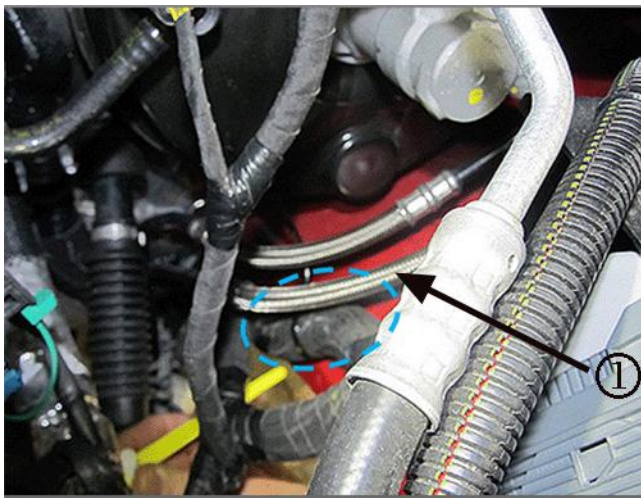
1. Open the hood, and in the area below the brake booster, inspect for contact between the chassis harness (noted by the yellow pointer) and the brake line (1).
