Service Bulletin

SUBJECT: Service Update for Inventory and Customer Vehicles
Torque Converter Machining Spill
Expires with Base Warranty

MODELS: 2015 Chevrolet Silverado HD
2015 GMC Sierra HD, Sierra Denali HD
Equipped with Allison 6-speed Automatic Transmission (RPO MW7)

Subject: 15435B – Service Update Bulletin
Torque Converter Machining Spill
Part Information Revised

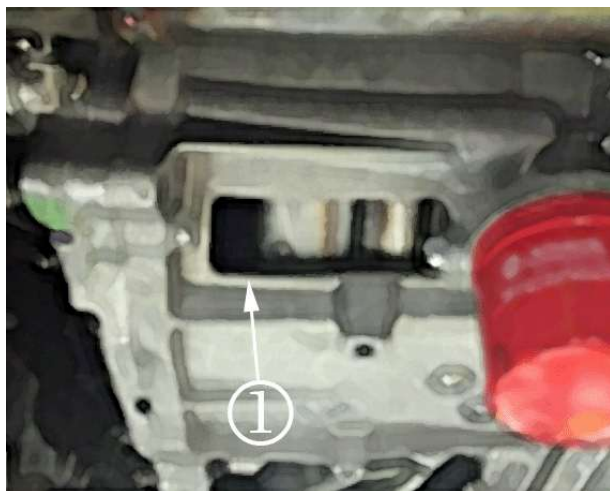
4212661

2. Locate the transmission access cover. The access cover is located on the bottom side of the transmission on the driver side of the vehicle.
3. Remove the access cover from the bottom of the transmission to expose the 25 mm (1 in) x 51 mm (2 in) inspection window (1).
4. Rotate the torque converter clockwise using the engine crankshaft damper bolt until a white label appears in the inspection window.

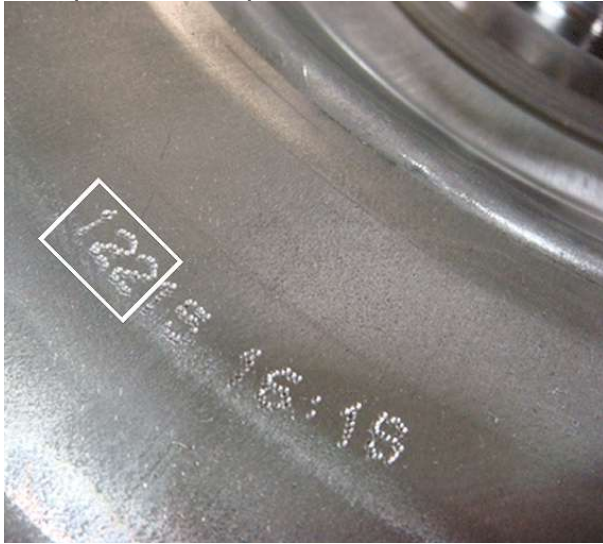
4212662

5. Rotate the torque converter clockwise an additional 180 degrees to reveal the Julian date stamp on the torque converter.

For torque converters built during the 2015 calendar year, inspect the first 3 digits of the Julian date, which are identified in the box, to determine if the torque converter must be replaced.

6. Use a light with a mirror or a borescope to read the Julian date.
- If the last two digits are 15 and the first three digits of the Julian date are 123, 124, 125, 126 or 127, the torque converter will need to be replaced. Proceed to step 7.
 - If the last two digits are 15 and the first three digits **are anything but 123, 124, 125, 126 or 127**, the torque converter does NOT require replacement. No further action is required. Install the transmission access cover and lower the vehicle. Refer to *Lifting and Jacking the Vehicle* in SI.
 - If the last two digits are 14 the torque converter does NOT require replacement. No further action is required. Install the transmission access cover and lower the vehicle. Refer to *Lifting and Jacking the Vehicle* in SI.
