MODEL
**2014~2015MY
Sorento (XMα)**

NUMBER
PS375

SUBJECT: SORENTO (XMα)- INTERMITTENT NO CRANK/START

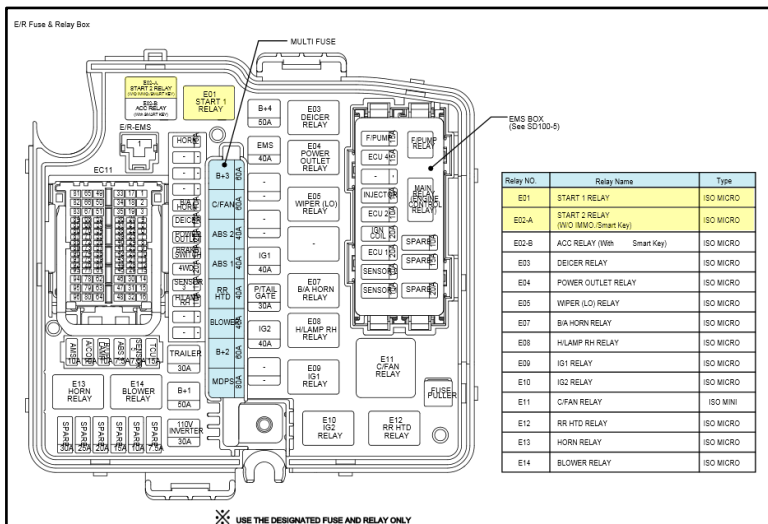
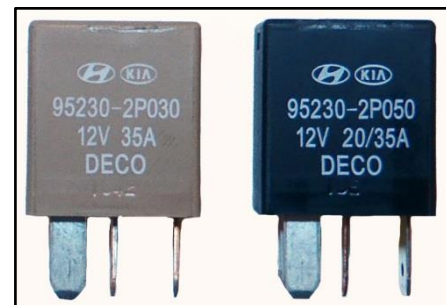
On some 2014-2015MY Sorento (XM), customers may experience a concern related to an intermittent no crank/start, especially after an overnight cold soak. To address this concern, replace both Start 1 and Start 2 relays in the fuse box by referring to the appropriate Service Information on KGIS.

Part Number	Description
95230 2P030	Start 1 Relay
95230 2P050	Start 2 Relay

NOTE: This concern is not related to TSB ELE 069 and TSB ELE 057 / SA163A for vehicles equipped with PTG. Before replacing Start 1 and Start 2 relays, ensure that the battery is in good operating condition to rule out the possibility of no crank/start due to intermittent parasitic draw.
