Program Bulletin

CUSTOMER SATISFACTION PROGRAM

SUBJECT: Navigation Radio Loss of Customer Settings

Subject: 13322B - Customer Satisfaction Program
Navigation Radio Loss of Customer Settings
Vehicles Involved and Service Procedure Revised

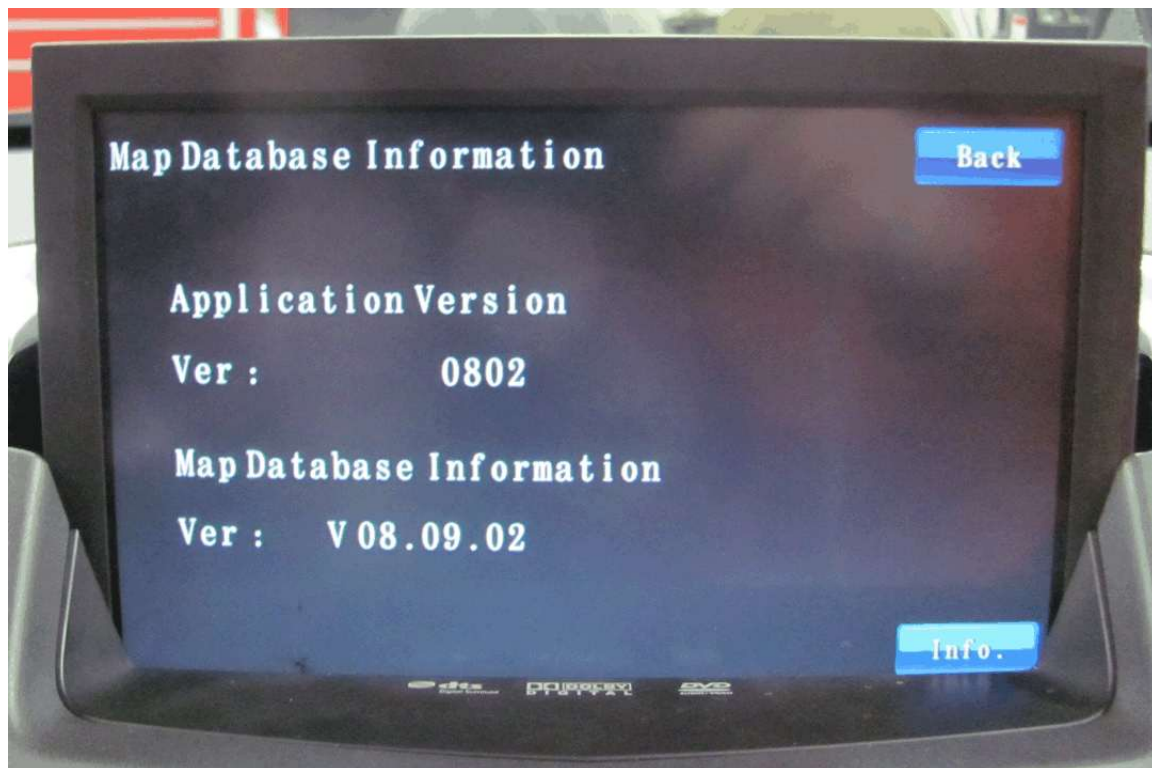
4068017

To determine the radio control module software version, navigate to the Map Database Information screen using the radio. Use the following navigation path: CONFIG>NAV>Map Database Information. Refer to the Application Version field on screen to determine the software version. Refer to photograph.

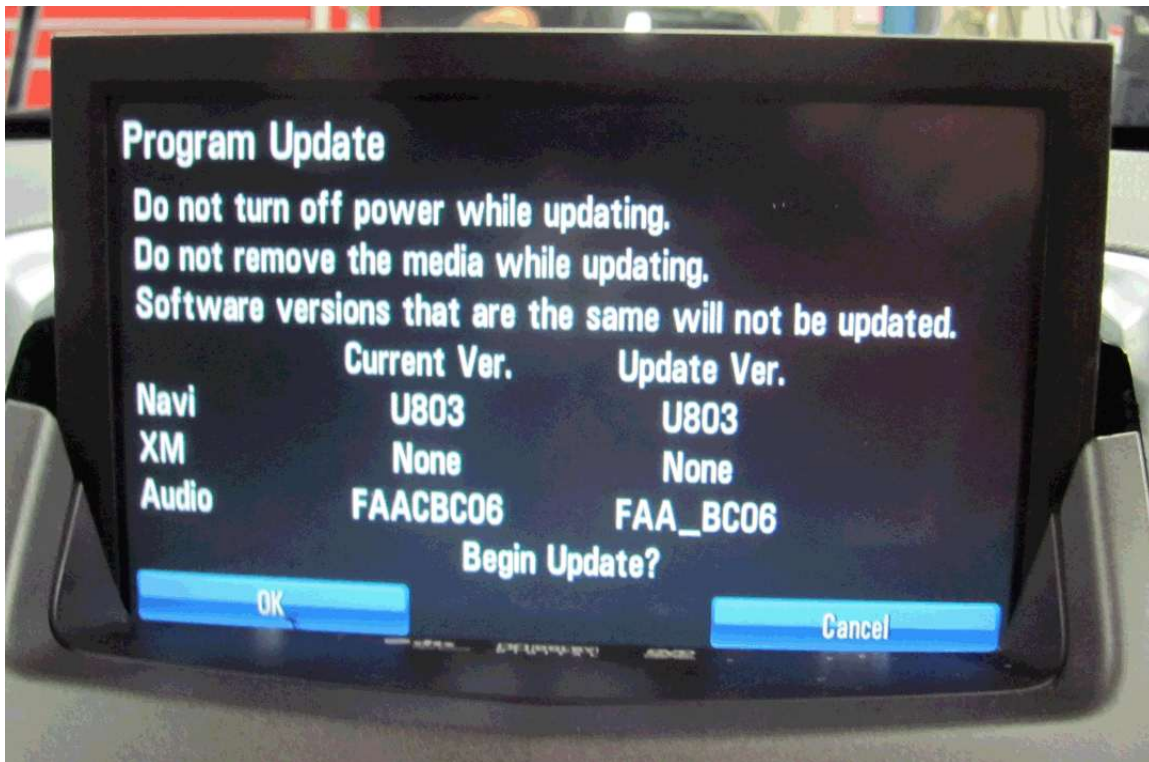
4068016

12. When the programming event has completed, the radio will display Download Complete.

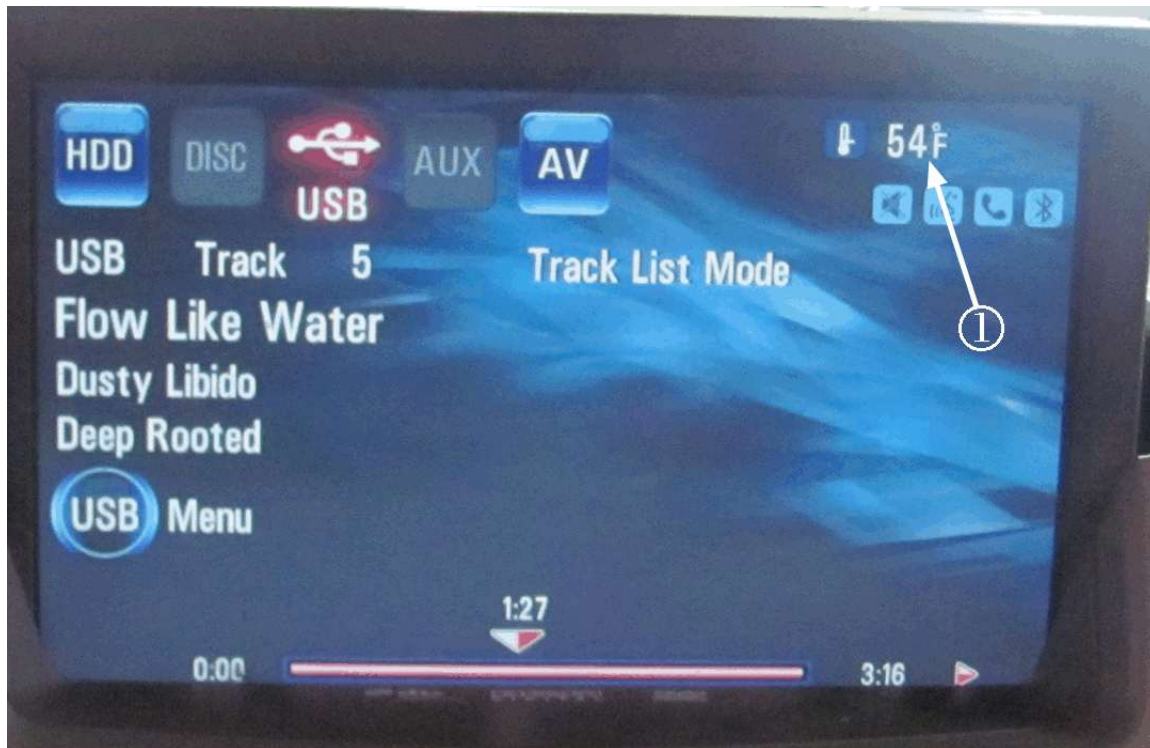
4011389

16. Determine if the temperature (1) is displayed on the radio and map screens.

- If the temperature (1) is displayed on the radio and map screens, no further action is required.
- If the temperature (1) is NOT displayed on the radio and map screens, a radio calibration MUST be performed. Proceed to step 17.
