Service Bulletin

SUBJECT: Special Coverage Adjustment – Negative Battery Cable Loose

MODELS: 2011-2015 Chevrolet Cruze

Subject: 14311A – Special Coverage Adjustment
Negative Battery Cable Loose
Revised Service Procedure Section

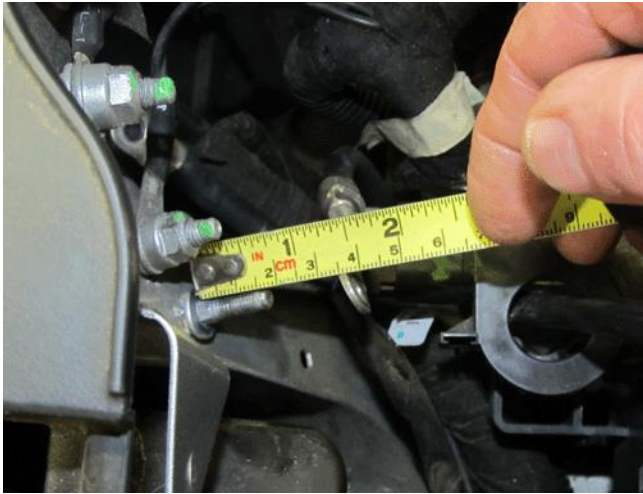
4002404

Note: When installing the body end of the new ground cable, depending on production date, the G100 ground stud could be one of two lengths. The shorter stud length of 17mm is shown in the graphic above.

13. Before installing the negative cable and starter ground cable to the G100 ground stud, measure the length of the stud. The information below will provide direction as to the correct nut to use for attachment

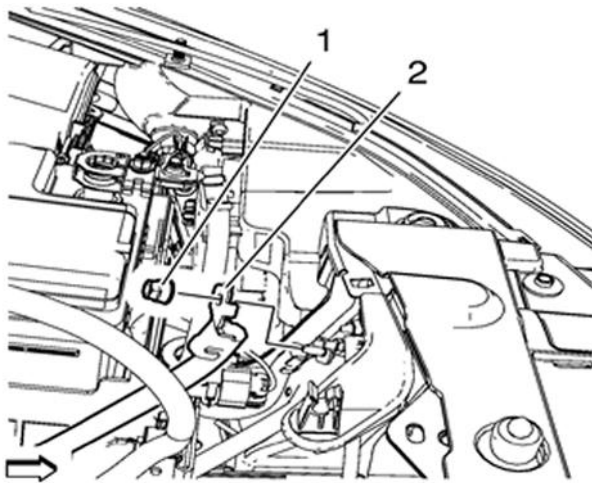
4002395

Note: In some cases, the terminal eyelet for ground cable from ground G100 to the starter may have an interference fit to the hex feature at the base of the G100 weld stud. Inspect for this condition during the following step.

14. Install the battery negative cable (2) onto the G100 ground stud, then install the terminal eyelet for the starter ground cable on top of the negative cable.
 - If no interference is found and the eyelet fully seats on the weld stud, skip step 15, and move ahead to step 16.
