Bulletin No.: 14567
Date: June 2015

Service Bulletin

SUBJECT: Special Coverage Adjustment - Rear Seat Belt Buckle Damage

MODELS: 2013-2015 Chevrolet Trax
2013-2015 Buick Encore

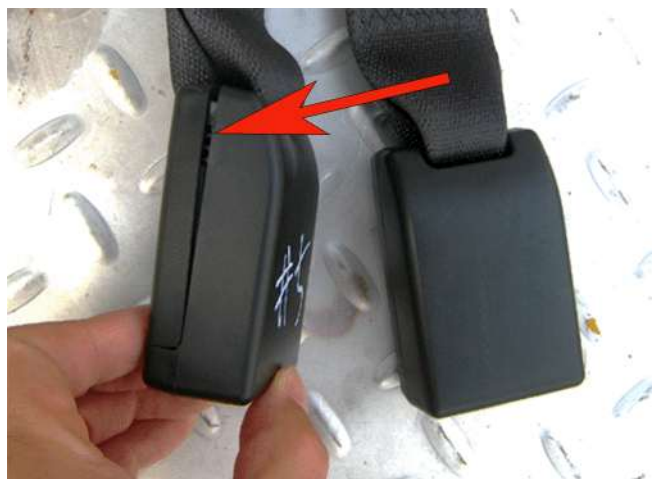
4213814

1. Move the front seats to the forward most position.
2. Pull the release strap and flip the lower seat cushion forward on both rear seats.
3. Verify which buckles are damaged and require replacement. Use the photos below to identify buckles that are no longer serviceable.

1. Replace the buckle assemblies that are no longer serviceable. Refer to *Rear Seat Belt Buckle Replacement* in SI.
