GROUP Chassis	MODEL 2014MY Sportage (SL)
	NUMBER 057	DATE April 2015
TECHNICAL SERVICE BULLETIN		
SUBJECT: TPMS SENSOR REPLACEMENT

TPMS SENSOR REPLACEMENT

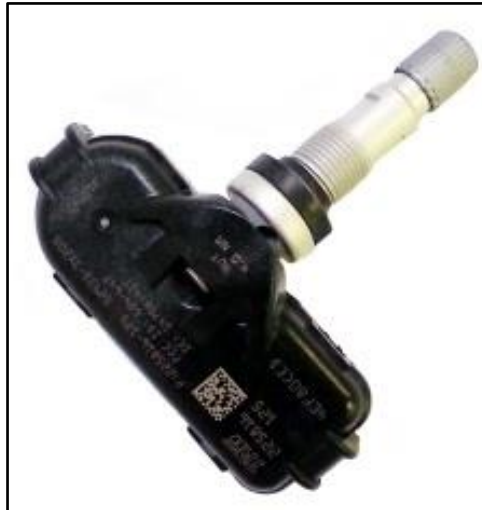
This bulletin provides the procedure to replace the TPMS sensors on some 2014MY Sportage (SL) vehicles, produced from September 1, 2013 through July 1, 2014, which may exhibit a TPMS light illuminated in the cluster, along with DTC C1212 - Vehicle Speed Sensor. To correct this concern, replace all four (4) TPMS sensors with the improved parts, by following the procedure outlined in this bulletin.

DTC C1212 – Vehicle Speed Sensor
