Program Bulletin

CUSTOMER SATISFACTION PROGRAM

SUBJECT: Backup Alarm Not Installed On Vehicle

MODELS: 2015 Chevrolet Colorado
2015 GMC Canyon
Equipped with Backup Alarm (SEO 8S3)

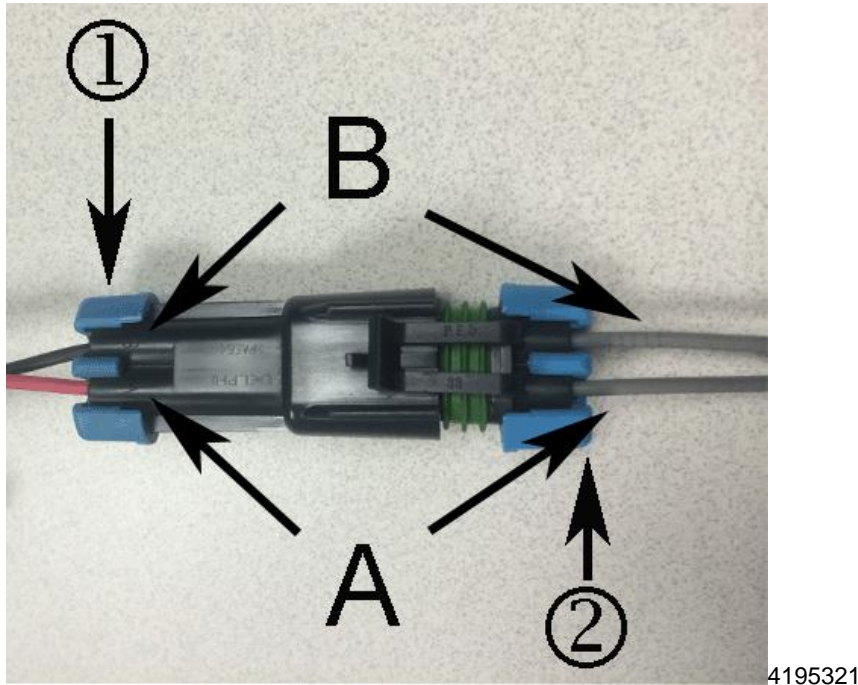
Backup alarm connector (1) terminals A/B shown with 12101855 connector (2).

8. Strip approximately 5.0 mm (0.20 in) of insulation from the end of each 12101855 connector wire.
9. Splice 12101855 connector wire going to terminal A of alarm to the thin gray wire (CKT 1624) of the vehicle harness with the salmon 19300089 Duraseal connector. Refer to *Splicing Copper Wire Using Splice Sleeves* in SI for splicing instructions.

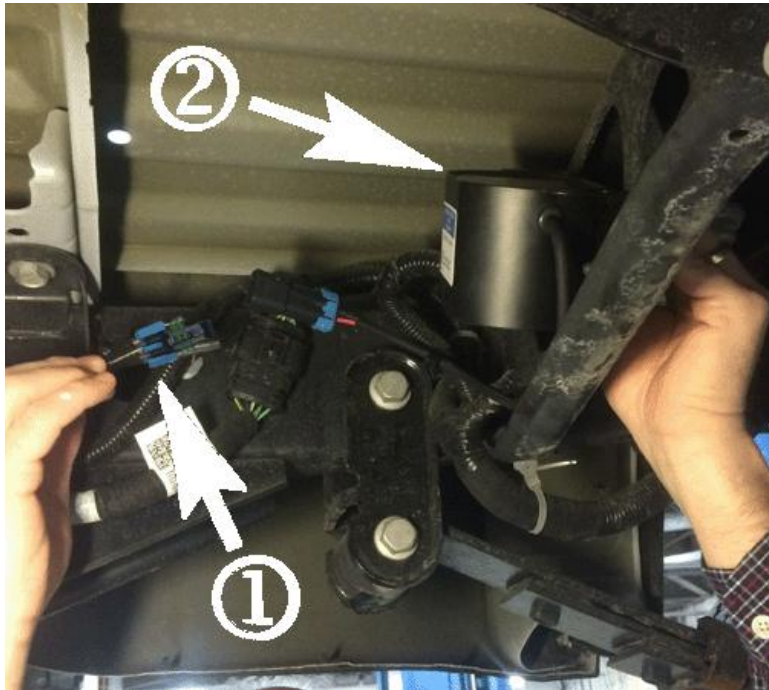
4195326

Backup alarm (2) and harness connector (1).

16. Install the backup alarm to the existing holes of the rear frame crossmember with the mounting nuts and bolts. The crossmember mounting location is near the leaf spring rear shackles. The alarm speaker must be pointing down.
17. Connect the rear harness connector (1) to the alarm (2) harness.
18. Tie strap the complete alarm harness to the existing wiring harness, securing it every 3 inches.
19. Lower the vehicle.
20. Connect the negative battery cable. Refer to *Battery Negative Cable Disconnection and Connection* in SI.
21. Turn the ignition to ON/RUN, and place gear selector into REVERSE to engage the backup alarm.
22. Raise the vehicle and install the spare tire. Refer to *Spare Wheel Carrier Hanger Replacement (Pickup)* in SI.
