**SUBJECT:** Service Update for Inventory and Customer Vehicles  
Rear Brake Line Bracket Bolt to Rear Axle Loose  
Expires with Base Warranty

**MODELS:** 2014-2015 Chevrolet Silverado LD  
2015 Chevrolet Silverado HD  
2014-2015 GMC Sierra LD  
2015 GMC Sierra HD  
2015 GMC Sierra Denali LD

Subject: 15203 – Service Update Bulletin  
Rear Brake Line Bracket Bolt to Rear Axle Loose

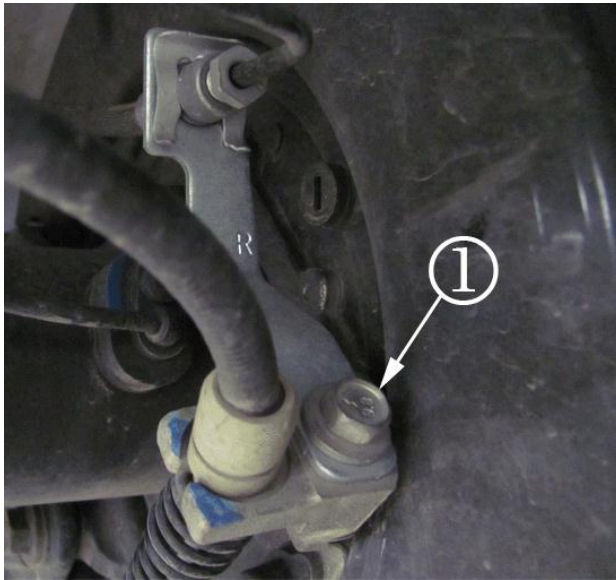
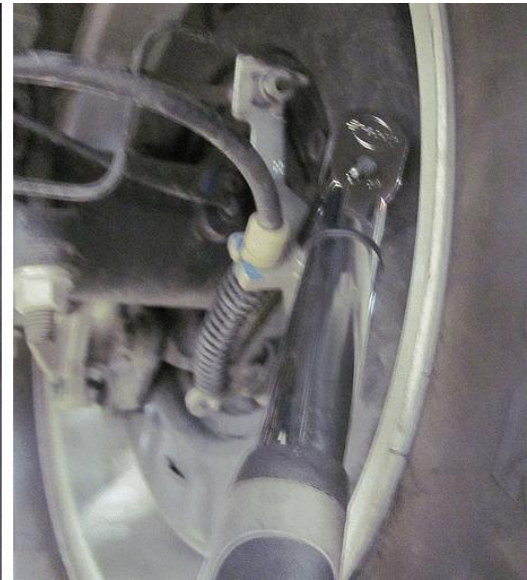
4204740

3. Inspect right rear brake line bracket bolt (1) to rear axle for proper torque. Ensure bolt is tightened to 25 Nm (18 lb ft).
4. Lower the vehicle. Refer to *Lifting and Jacking the Vehicle* in SI.

**Caution:** If the brake line bracket bolt is damaged or missing, replace it with a new bolt to avoid damaging the brake line or brake line bracket.
