Service Bulletin

SUBJECT: Service Update for Inventory and Customer Vehicles
Rear Brake Line Bracket Bolt to Rear Axle Loose
Expires with Base Warranty

MODELS: 2014-2015 Chevrolet Silverado LD
2015 Chevrolet Silverado HD
2014-2015 GMC Sierra LD
2015 GMC Sierra HD
2015 GMC Sierra Denali LD

Subject: 15203A – Service Update Bulletin
Rear Brake Line Bracket Bolt to Rear Axle Loose
Revised Service Procedure Section

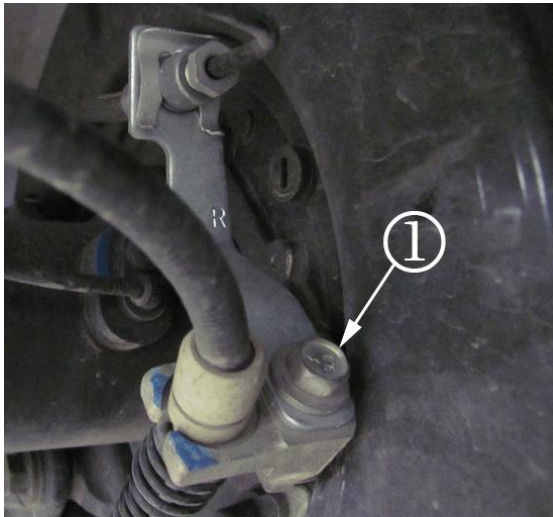
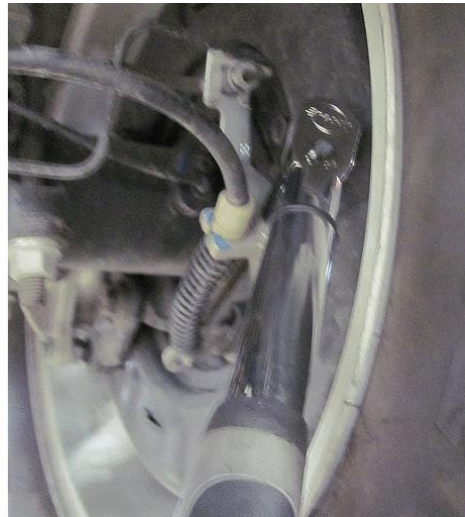
4204740

2014-2015 LD Truck Brake Line Bracket and Bolt (1)

Caution: If the brake line bracket bolt is damaged or missing, replace it with a new bolt to avoid damaging the brake line or brake line bracket.

3. Inspect right rear brake line bracket bolt (1) to rear axle for proper torque. Ensure bolt is tightened to 25 Nm (18 lb ft).
4. Lower the vehicle. Refer to *Lifting and Jacking the Vehicle* in SI.

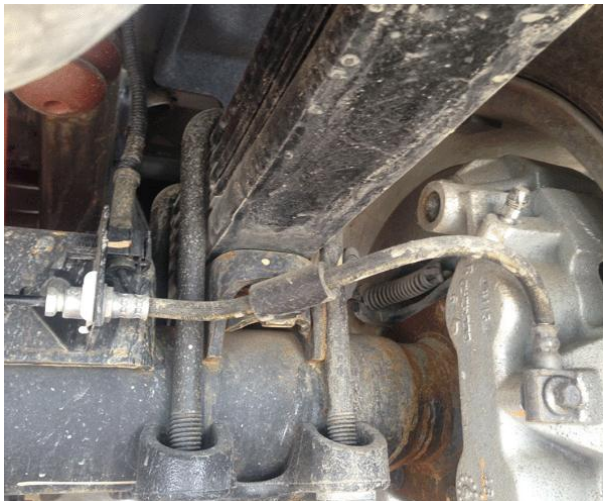
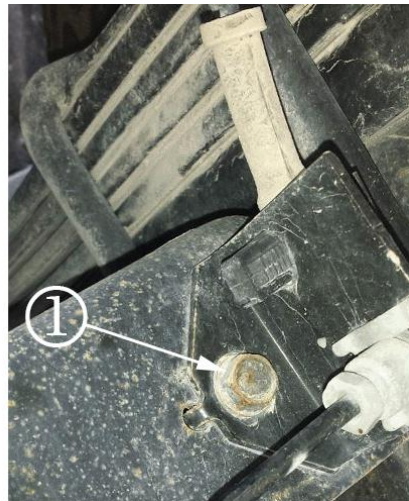
4214778

2015 HD Truck Brake Line Bracket and Bolt (1)
