Service Bulletin

SUBJECT: Service Update for Inventory and Customer Vehicles
Torque Converter Machining Spill
Expires with Base Warranty

MODELS: 2015 Chevrolet Silverado HD
2015 GMC Sierra HD, Sierra Denali HD
Equipped with Allison 6-speed Automatic Transmission (RPO MW7)

Subject: 15435A – Service Update Bulletin
Torque Converter Machining Spill
Revised Service Procedure

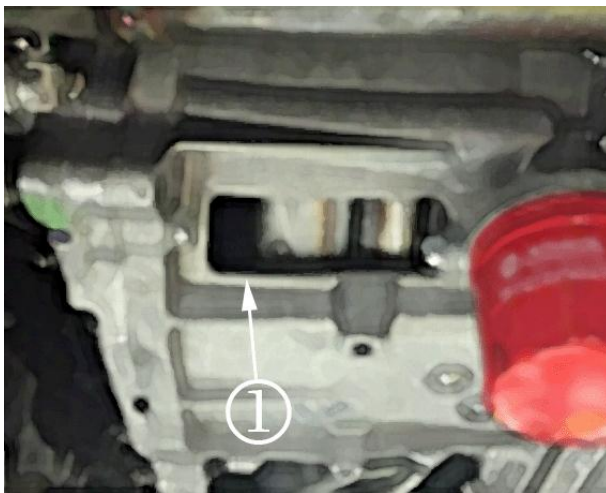
4212661

2. Locate the transmission access cover. The access cover is located on the bottom side of the transmission on the driver side of the vehicle.
3. Remove the access cover from the bottom of the transmission to expose the 25 mm (1 in) x 51 mm (2 in) inspection window (1).

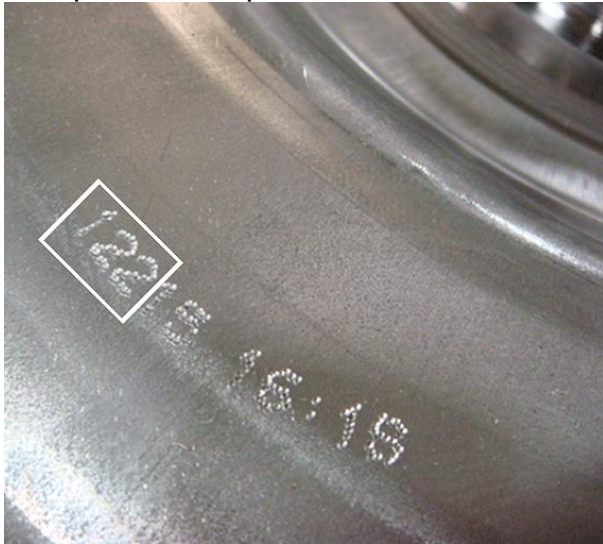
4212662

For torque converters built during the 2015 calendar year, inspect the first 3 digits of the Julian date, which are identified in the box, to determine if the torque converter must be replaced.

6. Use a light with a mirror or a borescope to read the Julian date.
 - If the last two digits are 15 and the first three digits of the Julian date are 123, 124, 125, 126 or 127, the torque converter will need to be replaced. Proceed to step 7.
 - If the last two digits are 15 and the first three digits **are anything but 123, 124, 125, 126 or 127**, the torque converter does NOT require replacement. No further action is required. Install the transmission access cover and lower the vehicle. Refer to *Lifting and Jacking the Vehicle* in SI.
 - If the last two digits are 14 the torque converter does NOT require replacement. No further action is required. Install the transmission access cover and lower the vehicle. Refer to *Lifting and Jacking the Vehicle* in SI.
