Service Bulletin

SUBJECT: Special Coverage Adjustment – Daytime Running Lamp Inoperative

**MODELS: 2007-2012 GMC Acadia
Equipped with High-intensity Discharge Headlamps (RPO TVD)**

Subject: 14823 – Special Coverage Adjustment
Daytime Running Lamp Inoperative

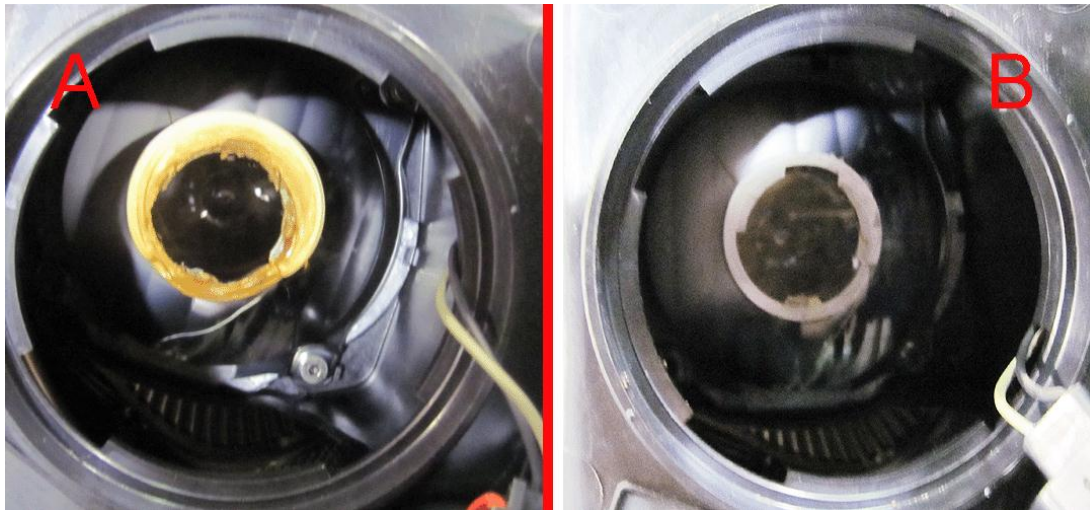
3034812

2. Remove headlamp bulb accessory cover.
3. Disconnect the electrical connector from the bulb socket.
4. Disconnect the bulb socket from the headlamp assembly.

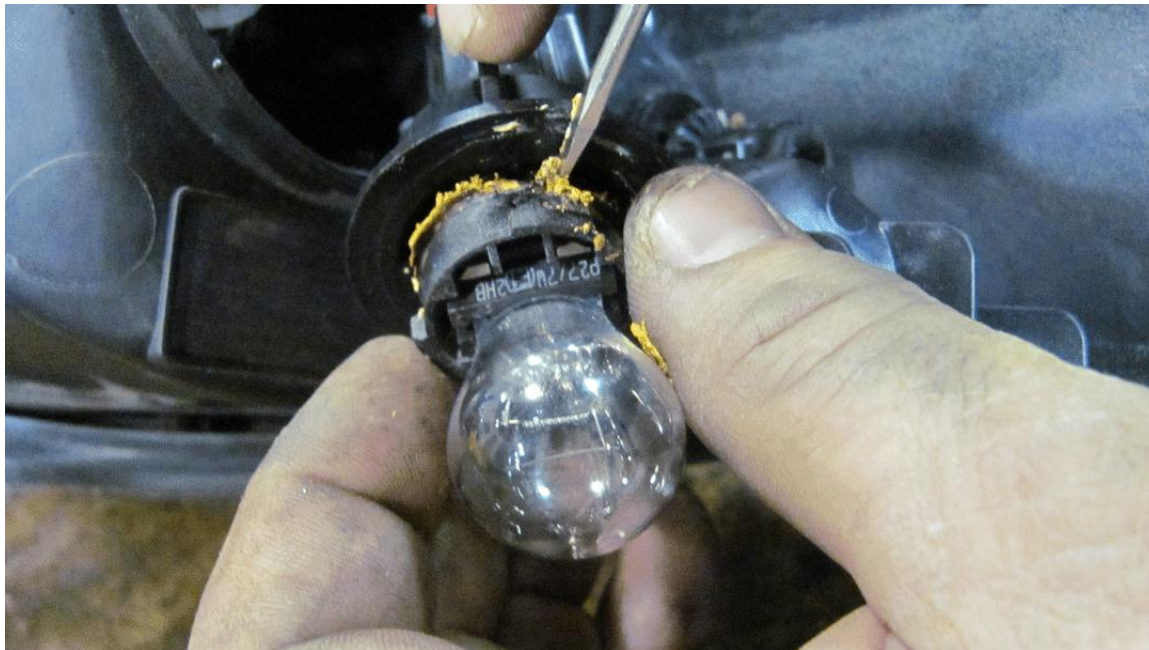
3035227

The “A” portion of the illustration shows the old gasket. The “B” portion of the illustration shows a clean bulb reflector.

5. Remove old gasket on the bulb reflector using a shop towel and cleaner.

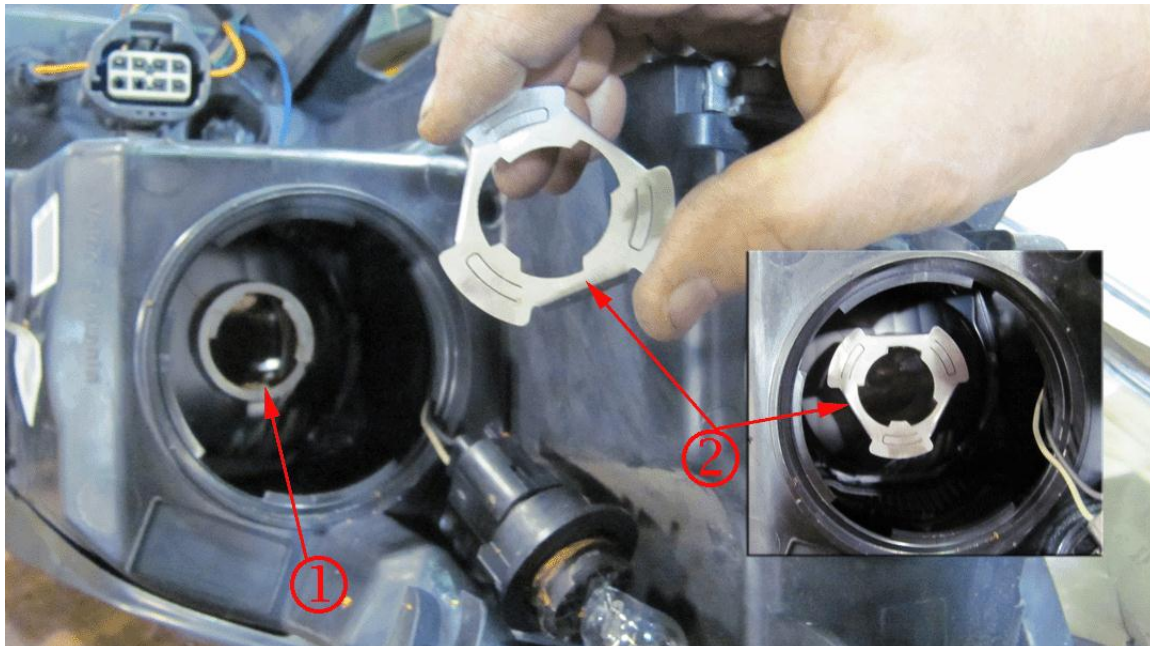
3035516

7. Inspect the reflector lugs (1) for damage, such as cracking, warping, or looseness.
 - If the headlamp reflector lugs (1) are NOT cracked, warped, loose or missing, install the reinforcement plate kit. Refer to 'A' portion of the photograph. The 'A' portion of the photograph shows usable reflectors lug. Do NOT replace the headlamp. Proceed to step 8.
 - If the headlamp reflector lugs (1) are cracked, warped, loose or missing, replace the headlamp. Refer to the 'B' portion of the photograph. The 'B' portion of the photograph shows an unusable reflector lug. The upper lug missing. Proceed to step 13.

Note: Only replace the headlamp if the reflector lugs are damaged or missing.
