GM Bulletin No.: 15190
Date: May 2015

SUBJECT: Service Update for Inventory and Customer Vehicles
Body Harness Pinch by Seat Belt Bracket at C-Pillar
Expires with Base Warranty

MODELS: 2015 Chevrolet Colorado
2015 GMC Canyon

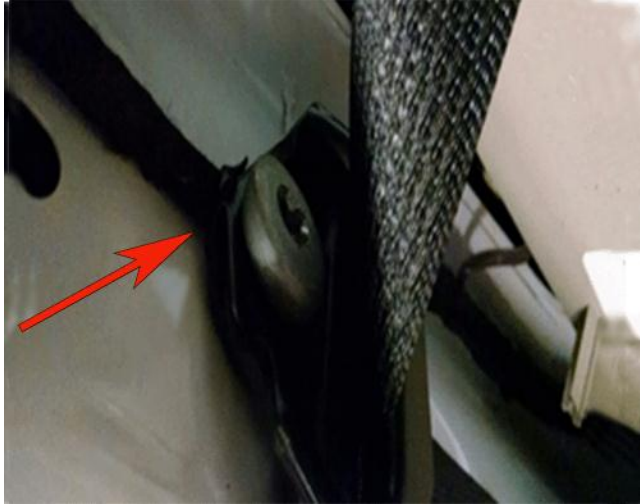
4192982

A branch of the body wiring harness may be trapped under the upper rear seat belt pivot bracket. Use the following steps to inspect the left and right rear seat belt bracket mounting area located in the upper “C” pillar area of the vehicle. If the seat wiring harness is not trapped, no further action is necessary. If the wiring harness is trapped, proceed to the repair steps.

Example of Trapped Harness (Pillar Trim Removed For Photo)
