# Service Bulletin

**SUBJECT:** Service Update for Inventory and Customer Vehicles  
Auto-Leveling Rear Suspension Inoperative  
Expires with Base Warranty

**MODELS:** 2015 Chevrolet Suburban, Tahoe  
2015 GMC Yukon, Yukon XL  
2WD Vehicles Equipped with Auto Leveling Rear Suspension  
(RPO Z85 and AVF)

Subject: 15303 – Service Update Bulletin  
Auto-Leveling Rear Suspension Inoperative

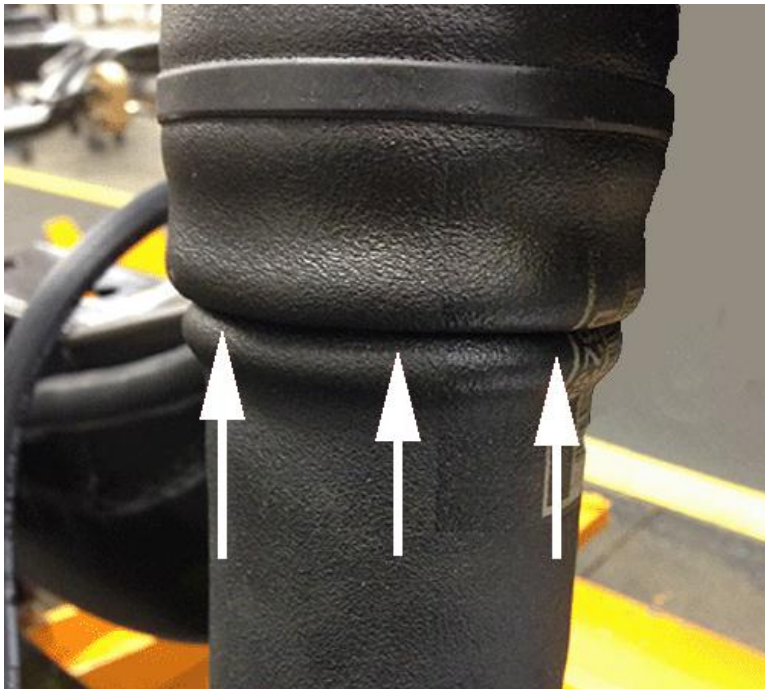
4180564

### **Air Sack Damage**

- Arrows point to trapped air sack between the shock body and the dirt shield. If this condition exists, the shock must be replaced. Inspect for rolling, folding, or any kinks in the rubber tube. Any shock with these conditions must be replaced.

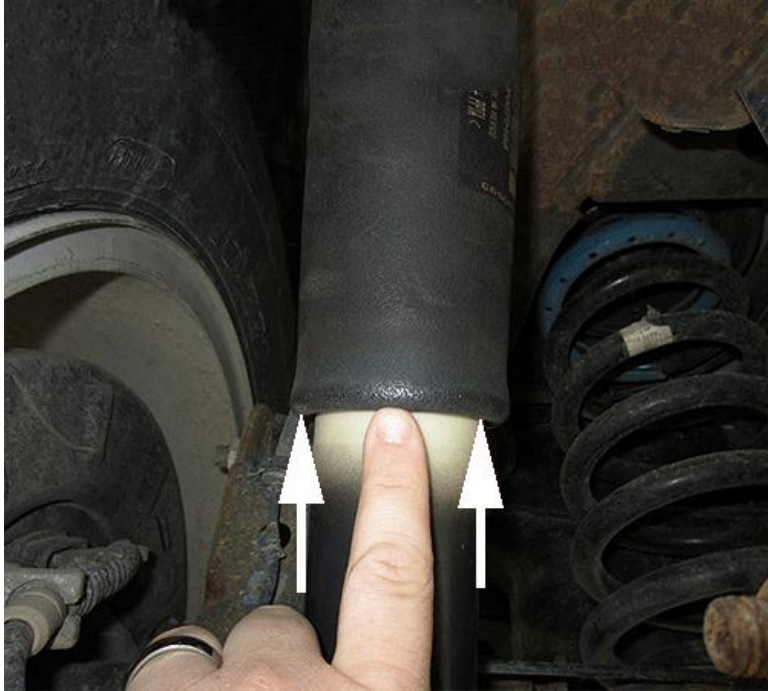
4180565

2. Raise and support the vehicle, with the rear axle unsupported to allow the rear shocks to extend. Refer to *Lifting and Jacking the Vehicle* in SI
3. Inspect the lower roll of the air sack. Some “polishing” of the rubber (as seen in the picture below) is normal and ok.
  - If the sack exhibits any cracking, splitting, peeling, is darker than the surrounding rubber, or shows any spalling or material loss, it is damaged and must be replaced

### **Air Sack Damage**

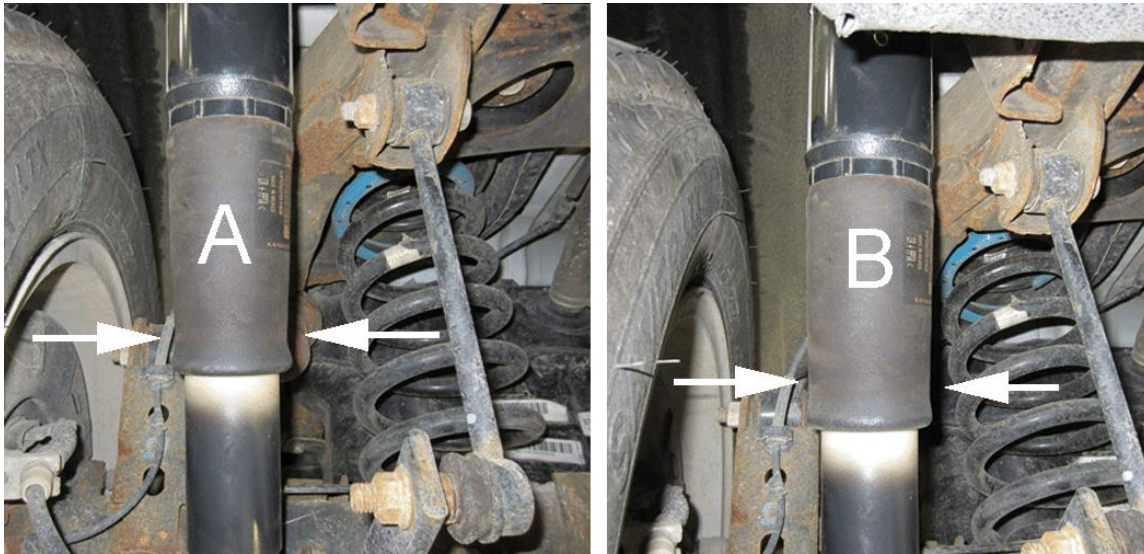
4180560

### Check System Pressure

- Check shock absorbers for system pressure. Shock “A” has no pressure, and displays a tapered “waist” just above the bottom roll of the boot. Shock “B” has the correct pressure with a nearly uniform width top to bottom.

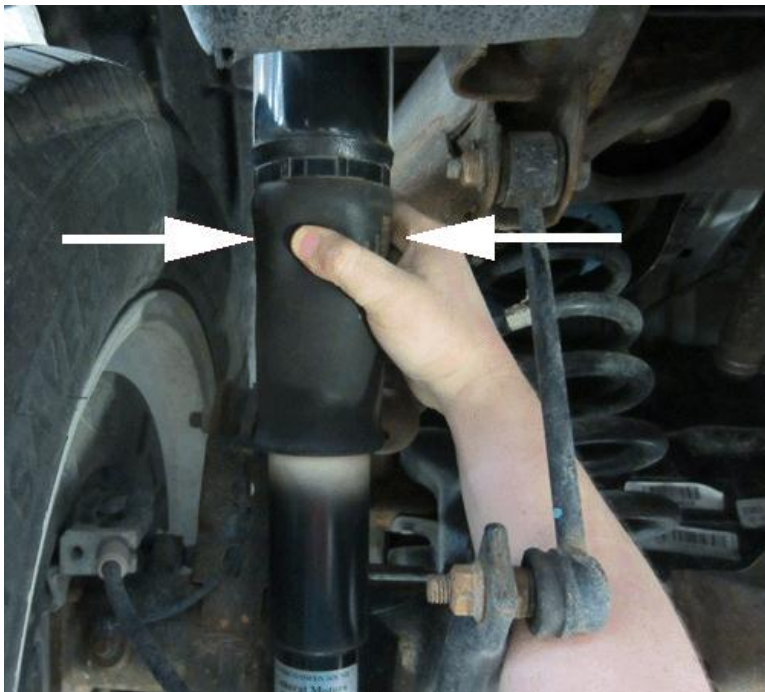
4180563

### Air Sack Pressure Check

- Squeeze the air sack. The more firm the sack, the more pressure is present. If, after pressurizing the system the air sack is not holding pressure, it is damaged and must be replaced.

For rear shock absorber replacement refer to *Rear Leveling Shock Absorber Replacement* in SI. Replace shocks in pairs.
