GM Bulletin No.: 15401  
Date: May 2015

# Service Bulletin

**SUBJECT:** Service Update for Inventory and Customer Vehicles  
Front Driver and Passenger Seat Plate Nut Thread Quality  
Expires with Base Warranty

**MODELS:** 2015 Buick Enclave  
2015 Chevrolet Traverse

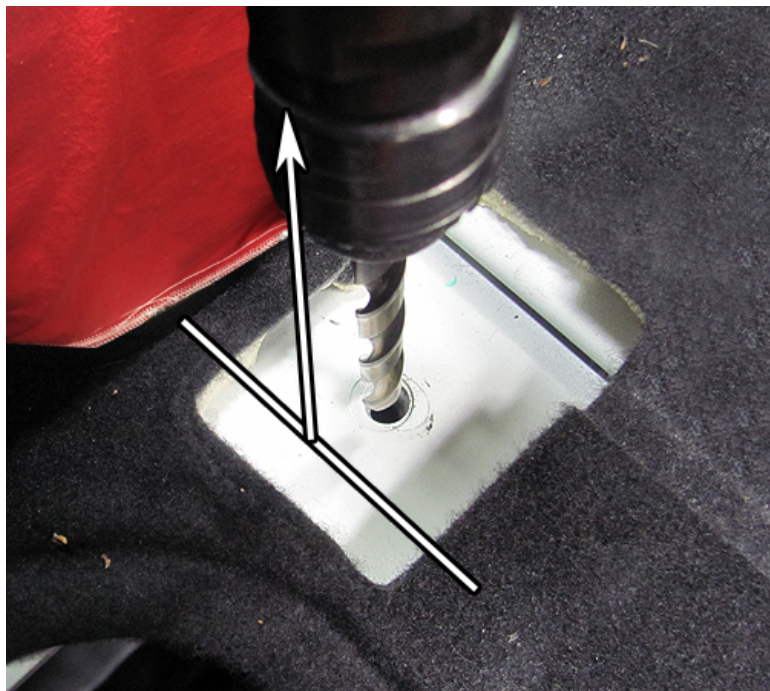
4200509

**Note:** Enlarging the holes requires drilling close to the center console. Use a compact drill to maintain a vertical drilling angle aligned to the holes.
