Service Bulletin

SUBJECT: Special Coverage Adjustment – Ignition Key Removal

MODELS: 2005-2006 Chevrolet Equinox
2006 Pontiac Torrent
2002-2007 Saturn VUE

Subject: 14319A – Special Coverage Adjustment
Ignition Key Removal
Vehicles Involved Revised

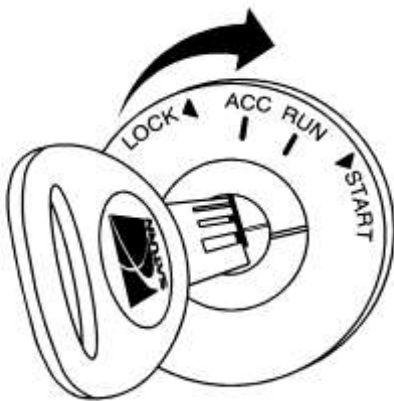
1334808

Note: Some Saturn VUE vehicles may have a condition in which the ignition key can be removed when the ignition is NOT in the LOCK position.

Note: With the key in the ignition switch, you can turn it to four different positions. **You should only be able to remove the key when the ignition is turned to the LOCK position.** Below is a description of the four ignition positions:

1. Determine if the key can be removed from the ignition cylinder in any position other than the LOCK position.
 - If the key **cannot** be removed in any position other than the LOCK position, no further action is required.
 - If the key can be removed from the ignition cylinder while in the ACC, RUN or START position, replace the ignition lock cylinder and key set (2 keys). Proceed to step 2.
2. Remove the ignition lock cylinder. Refer to *Ignition Lock Cylinder Replacement* in SI.
3. Install a new ignition lock cylinder. Refer to *Ignition Lock Cylinder Replacement* in SI.

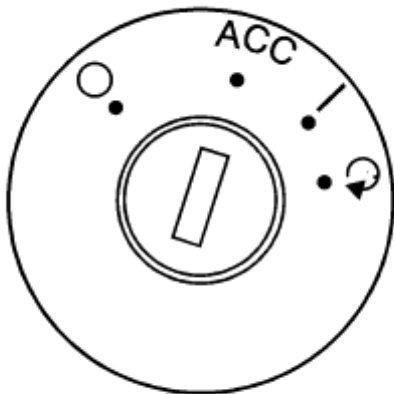
1839823

Note: Some Chevrolet Equinox and Pontiac Torrent vehicles may have a condition in which the ignition key can be removed when the ignition is NOT in the LOCK position.

Note: With the key in the ignition switch, you can turn it to four different positions. **You should only be able to remove the key when the ignition is turned to the LOCK position.** Below is a description of the four ignition positions:

1. Determine if the key can be removed from the ignition cylinder in any position other than the LOCK position.
 - If the key **cannot** be removed in any position other than the LOCK position, no further action is required.
 - If the key can be removed from the ignition cylinder while in the ACC, RUN or START position, replace the ignition lock cylinder and key set (2 keys). Proceed to step 2.
2. Remove the ignition lock cylinder. Refer to *Ignition Lock Cylinder Replacement* in SI.
3. Install a new ignition lock cylinder. Refer to *Ignition Lock Cylinder Replacement* in SI.
