Program Bulletin

CUSTOMER SATISFACTION PROGRAM

SUBJECT: Untreated Rivets and Poor Paint Finish on Underside of Hood

**MODELS: 2014 Buick Verano
2014 Chevrolet Sonic**

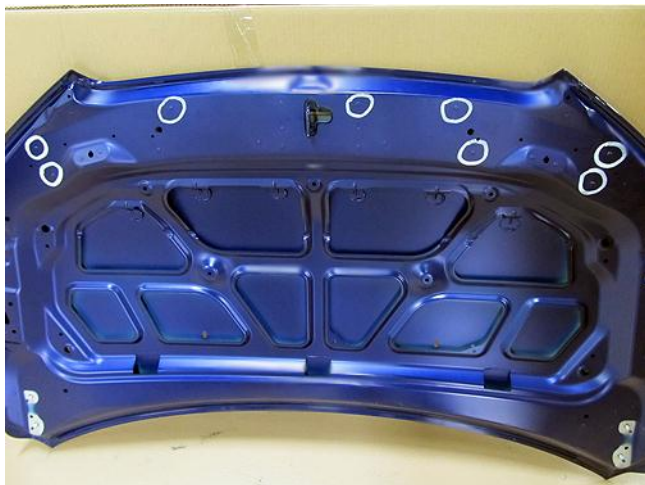
Sonic Rivet Locations

There are 10 rivet repair locations on the Sonic hood. 8 across the front and 2 at the right rear corner. Use the following graphics to insure all 10 locations have rivets. If any rivets are missing, use the Rivet Installation steps below to install the necessary rivets. If all of the locations have a rivet installed, proceed to the Finish Repair and Corrosion Protection Steps.

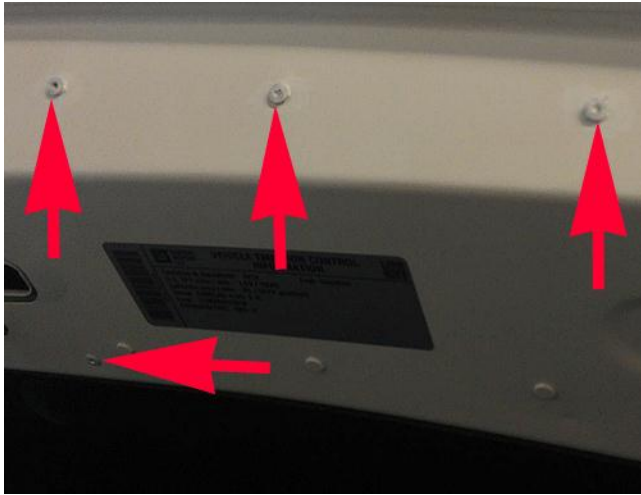
3966995

16. Inspect the appearance of the paint repair in the replacement rivet areas. These areas will need to be refinished.
17. Sand off the brush applied touch up paint as required. If any corrosion is present, repair as necessary before paint.
