GM Bulletin No.: 14818  
Date: April 2015

**SUBJECT:** Service Update for Inventory and Customer Vehicles  
Body Wire Harness Chafe  
Expires with Base Warranty

**MODELS:** 2015 Chevrolet Colorado  
2015 GMC Canyon

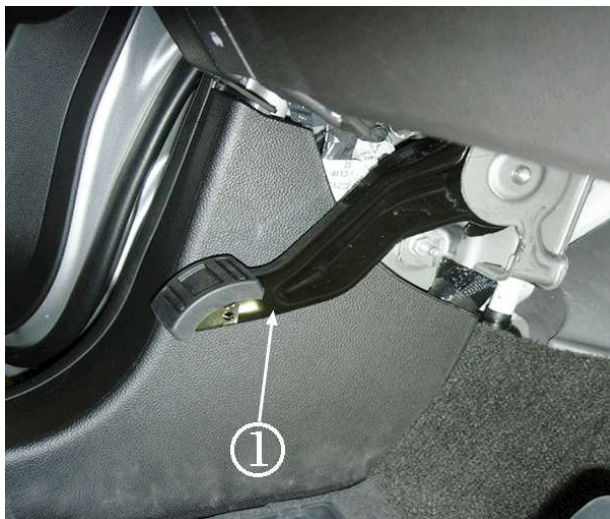
4147615

1. Locate the park brake pedal assembly (1). The park brake pedal assembly is located under the instrument panel on the driver side of the vehicle.

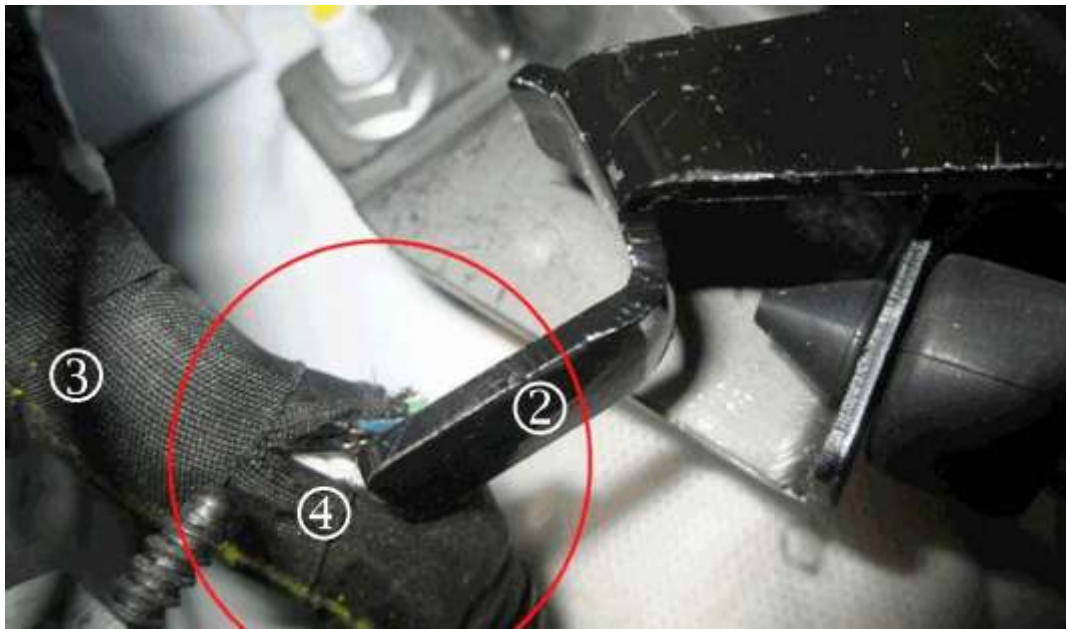
4147560

**Photograph shows a damaged (4) body wire harness. Note the contact between the park brake pedal assembly switch activating tab (2) and the body wire harness (3).**

2. Locate the park brake pedal assembly switch activating tab (2) and body wire harness (3).
3. Using a flash light determine if the body wire harness has been damaged (4) by park brake pedal switch activating tab.

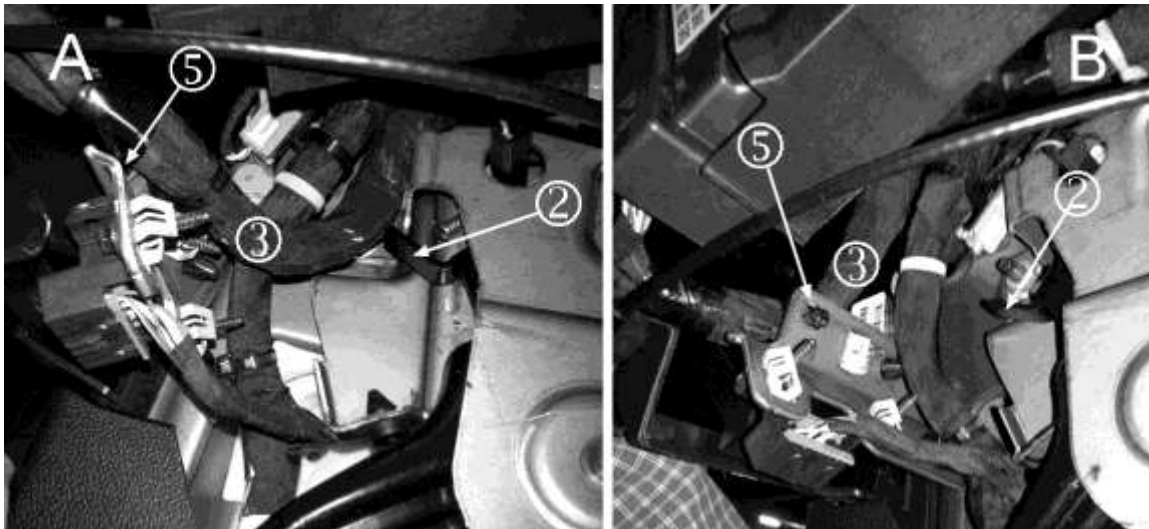
4165682

- (A) An incorrectly routed body wire harness. The body wire harness contacts the park brake pedal switch activating tab (2). The body wire harness is mounted on the front side of the bracket.
- (B) A correctly routed body wire harness. The body wire harness does NOT contact the park brake pedal switch activating tab (2). The body wire harness is mounted on the backside of the bracket.
8. Determine if the body wire harness is routed correctly. A correctly routed body wire harness will NOT contact the park brake pedal switch activating tab. In addition, the body wire harness clip on a correctly routed body wire harness is installed on the backside of the mounting bracket.

- If the body wire harness is routed correctly and it does NOT contact the park brake pedal assembly switch activating tab, no further action is required.
  - If the body wire harness is NOT routed correctly and it contacts the park brake pedal assembly switch activating tab, proceed to step 9.
9. Detach the body wire harness from the front side of the bracket and install the body wire harness clip to the backside of the bracket.

10. Ensure the body wire harness is routed correctly and does NOT contact the park brake pedal assembly switch activating tab.
