# Service Bulletin

**SUBJECT:** Service Update for Inventory Vehicles Only  
Transmission Gear Whine Noise  
Expires April 30, 2016

**MODELS:** 2015 Cadillac Escalade, Escalade ESV  
2015 Chevrolet Silverado LD Crew, Silverado LD Crew LTZ,  
Silverado LD Ext LTZ  
2015 GMC Sierra LD Crew, Sierra LD Crew Denali, Sierra LD Ext,  
Yukon, Yukon Denali, Yukon XL, Yukon XL Denali  
Equipped with 8-Speed Transmission (M5U) and 6.2L Engine (L86)

Subject: 15178 – Service Update Bulletin  
Transmission Gear Noise

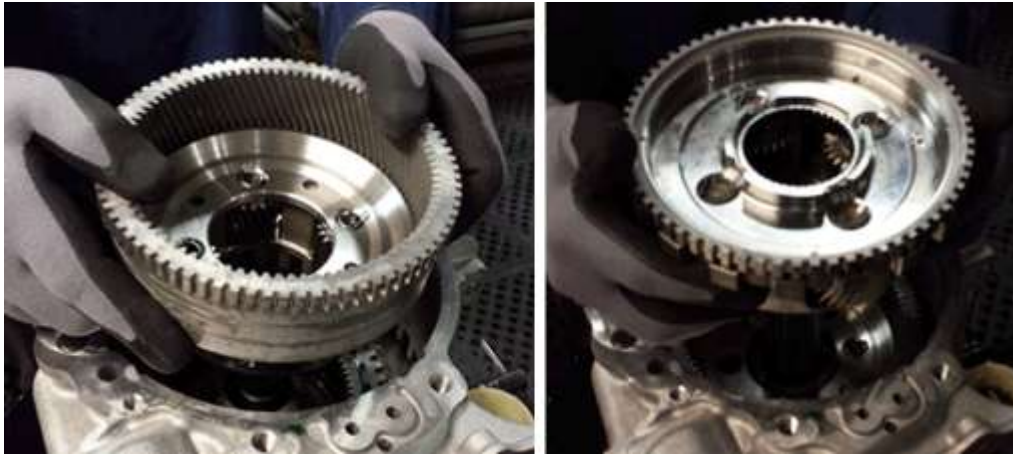
4121120

This bulletin provides a service procedure to perform a drive audit and, if necessary, replace the reaction/output carrier assembly and associated parts on certain 2015 model year Cadillac Escalade, Escalade ESV; Chevrolet Silverado LD Crew, Silverado LD Crew LTZ, Silverado LD Ext LTZ; and GMC Sierra LD Crew, Sierra LD Crew Denali, Sierra LD Ext, Yukon, Yukon Denali, Yukon XL, Yukon XL Denali vehicles equipped with an 8-speed transmission (M5U) and a 6.2L engine (L86). Some of these vehicles may exhibit a transmission gear whine noise at 1000-2000 RPM and between 20 mph (32 kph) and 35 mph (56 kph).

14. Remove the output carrier assembly.

15. Install the new output carrier assembly.
