# Service Bulletin

**SUBJECT:** Service Update for Inventory and Customer Vehicles  
TCM Harness Routing  
Expires with Base Warranty

**MODELS:** 2015 Chevrolet Silverado  
2015 GMC Sierra  
HD Vehicles Equipped with Dual Generators (KHB)

Subject: 15217 – Service Update Bulletin  
TCM Harness Routing

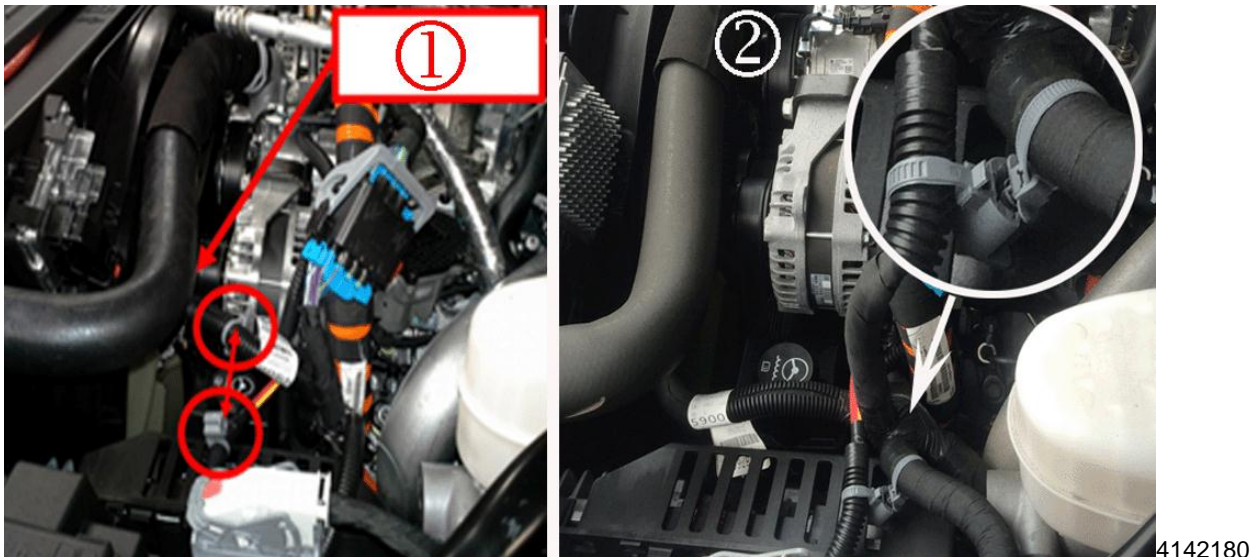
On these vehicles, the TCM branch of the engine-wiring harness may have been misrouted and not secured with an existing fir-tree clip on the auxiliary-positive battery cable, potentially allowing the harness to come in contact with either the auxiliary-generator pulley or belt.

**Note:** Item (1) shows the generator contact area of the TCM harness along with the disconnected two part clip. Item (2) shows the correctly fastened clip, retaining the TCM harness away from the generator.

2. Inspect the area to the left of the generator. Look for the gray two piece fir tree and buddy clip fastening the TCM harness to the auxiliary positive battery cable.
  - If the clip is fastened, no further action is needed.
  - If the clip is present but the two parts are not fastened, join the two parts of the clip.
  - If the clip is missing, or unable to be fastened, install a new fir tree fastener with tie straps on the harness to connect to the buddy clip.
  - If the TCM harness conduit is worn through at the serpentine belt, tape and secure the conduit in the affected area.
