# Service Bulletin

**SUBJECT: Special Coverage Adjustment – Loss of Steering Due to Water Intrusion (Steering Gear Umbrella Seal Missing)**

**MODELS: 2004-2005 Chevrolet Malibu, Malibu Maxx  
2005 Pontiac G6**

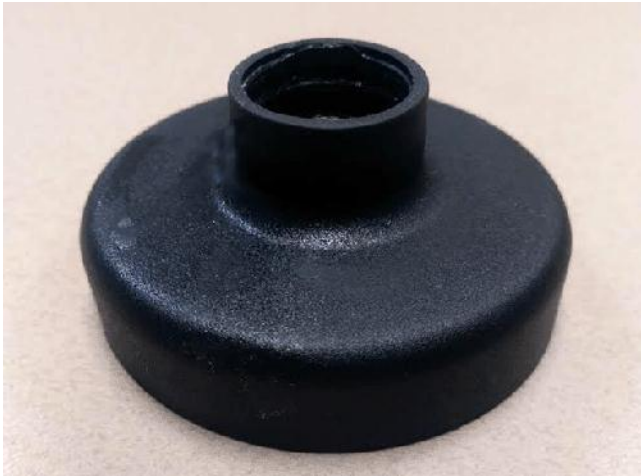
3984319

Use the following steps to inspect the steering gear input shaft for the presence of an “Umbrella Seal”. If no seal is installed, it will be necessary to replace the steering gear.

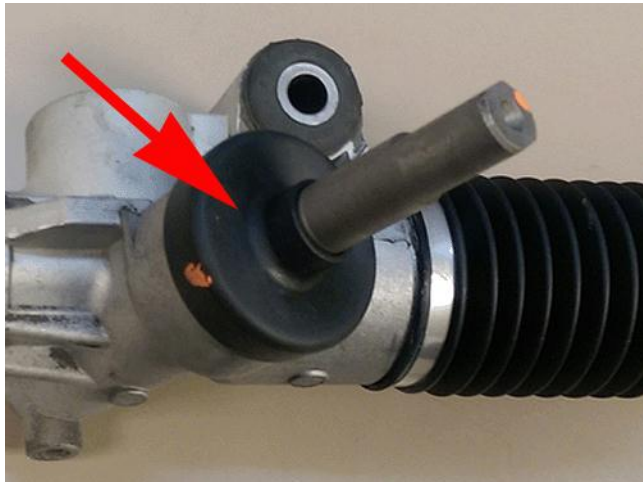
3984329

- If the seal **is** installed, no further action is required. Inform the customer that any additional diagnosis and repairs are not covered under this special coverage.

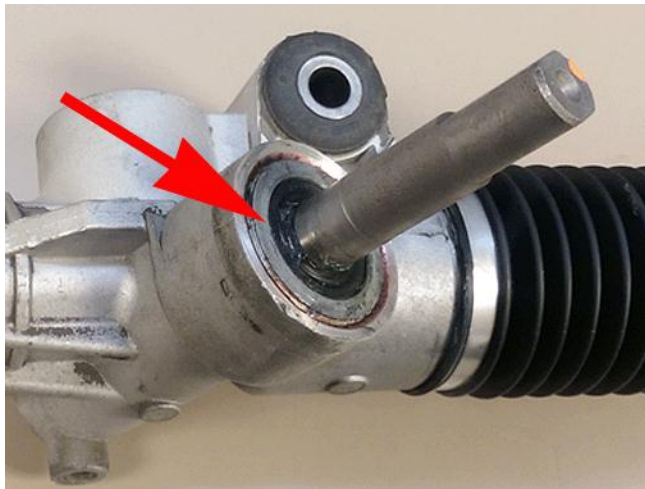
3984334

- If the seal is **not** installed, proceed to the *Steering Gear Replacement* section below.

If the vehicle does not have the seal installed, replace the steering gear assembly. Refer to *Steering Gear Replacement* in SI.
