# Service Bulletin

**SUBJECT:** Service Update for Inventory and Customer Vehicles  
OnStar® Cable Interference  
Expires with Base Warranty

**MODELS:** 2015 Chevrolet Equinox  
2015 GMC Terrain  
Equipped with Front Electronic Control HVAC System (C67/C68)

Subject: 14682 – Service Update Bulletin  
OnStar® Cable Interference

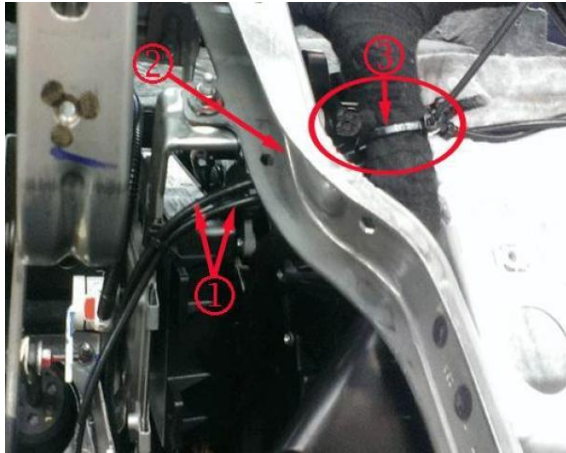
This bulletin provides a service procedure to reroute and secure the OnStar cable away from the HVAC mode door, and if necessary, replace the HVAC mode actuator on **certain** 2015 model year Chevrolet Equinox and GMC Terrain vehicles equipped with front electronic control HVAC system (C67/C68). The routing of the OnStar cable has the potential to interfere with the travel actuation of the mode door cam. This may cause a clicking noise under the instrument panel when switching HVAC modes or the system may not operate as expected.

3. Take both OnStar cables (1) and pull away from the HVAC mode door while routing under the instrument panel support (2) and tie strap them to the instrument panel harness (3).
4. Reinstall the driver knee bolster reinforcement. Refer to *Driver Knee Bolster Reinforcement Replacement* in SI.
5. Reinstall the instrument panel insulator panel. Refer to *Instrument Panel Insulator Panel Replacement* in SI.
6. Re-perform the HVAC system check to confirm that the HVAC system operation is fully functional as expected.
