SUBJECT: Service Update for Inventory and Customer Vehicles
Body Harness Contact with Park Brake Bracket
Expires with Base Warranty

MODELS: 2014-2015 Chevrolet Silverado
2014-2015 GMC Sierra

Subject: 14725A – Service Update Bulletin
Body Harness Contact with Park Brake Bracket
Revised Service Procedure

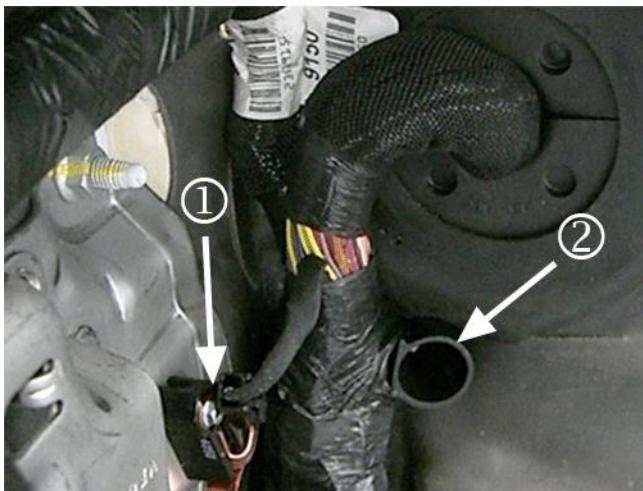
4109182

Note: The graphic above was taken with the junction block removed **for illustration purposes only**. Complete junction block removal is NOT necessary.

4. To gain slack on the harness, disconnect the park brake light warning switch terminal (1) and detach the harness retainer (2) from the body stud.
