GM Bulletin No.: 14770  
Date: March 2015

**SUBJECT:** Service Update for Inventory and Customer Vehicles  
Seat Wire Harness  
Expires with Base Warranty

**MODELS:** 2014-2015 Chevrolet Impala

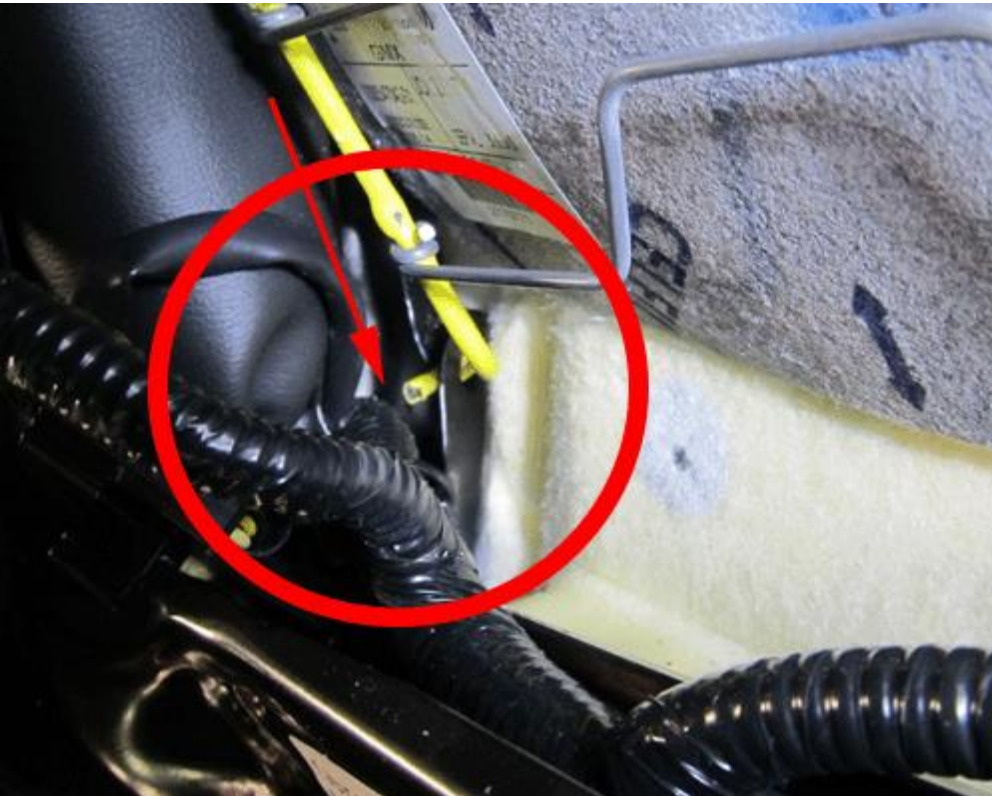
4001529

4. Disconnect the center section of the rear seat cover from the inboard and outboard cover. Raise the center section of the seat cover for inspection.
5. Inspect the wiring harness to seat back cushion pad wire clearance as shown.

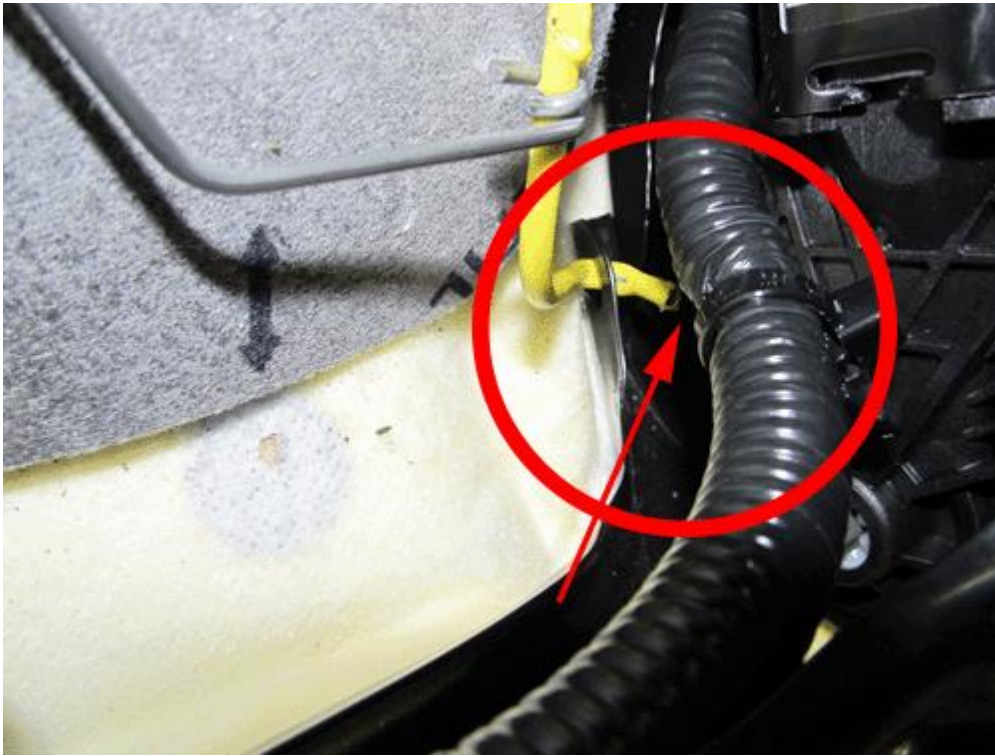
4001531

- If the harness is not contacting the cushion pad wire and there is a minimum of 10 mm clearance, proceed to the next step.

- If the harness is contacting the cushion pad wire or shows evidence of contact, proceed to the **Repositioning and Securing Seat Wiring Harness** section below.
6. Reconnect the center seat cover to side seat cover J-channels. Reconnect the lower seat cover to seat frame J-channels.
  7. Repeat steps 3-6 on the right front seat.
  8. Reconnect the negative battery cable. Refer to *Battery Negative Cable Disconnection and Connection* in SI.
  9. Reposition the seats into their original location.
