Service Bulletin

SUBJECT: Service Update for Inventory and Customer Vehicles
Incorrect Air Conditioning Vent Assembly
Expires with Base Warranty

MODELS: 2015 Cadillac XTS

Subject: 14891– Service Update Bulletin
Incorrect Air Conditioning Vent Assembly

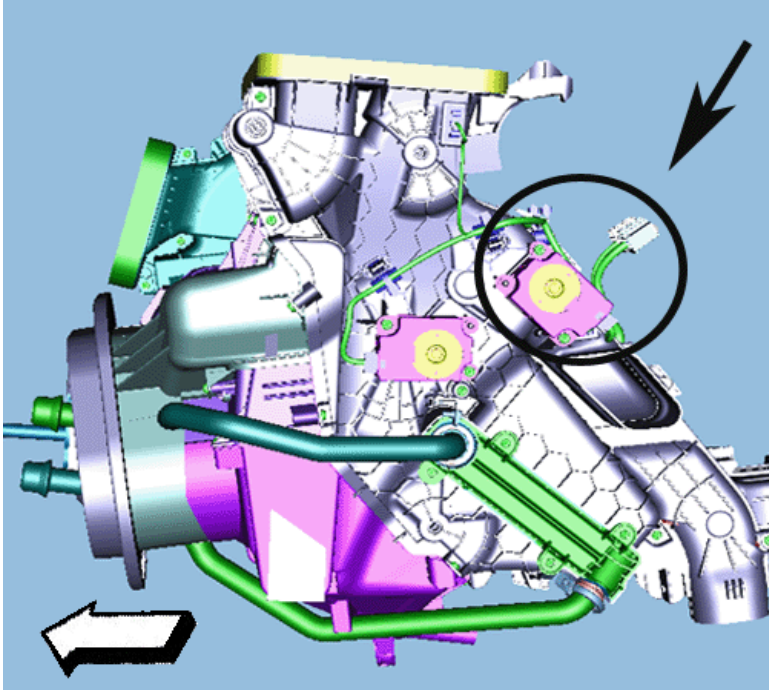
4090315

Reference: AC vent bypass door actuator location

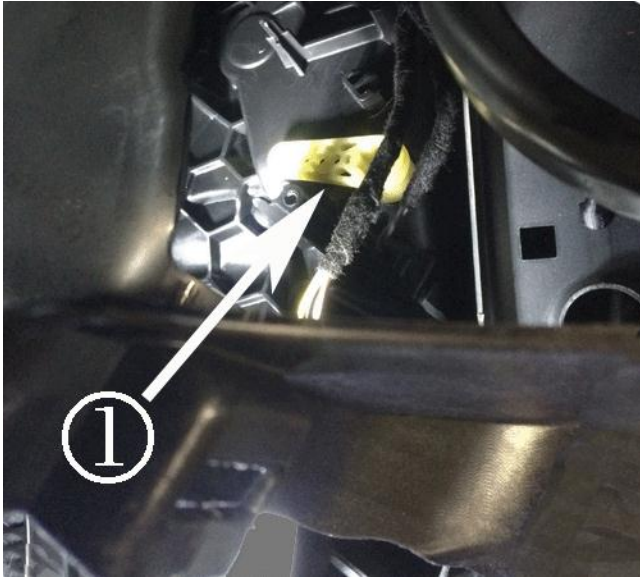
4091918

Driver Side Under dash shown

4. Rotate the bypass vent door shaft (1) counter-clockwise to the stop.
