SUBJECT: Service Update for Inventory and Customer Vehicles
Transfer Case Adapter Missing Lower Bolts
Expires with Base Warranty

MODELS: 2015 Chevrolet Colorado 4WD
2015 GMC Canyon 4WD
Equipped with 2.5L Engine (RPO LCV) and 6-Speed Automatic
Transmission (RPO MYB)

Subject: 15008 – Service Update Bulletin
Transfer Case Adapter Missing Lower Bolts

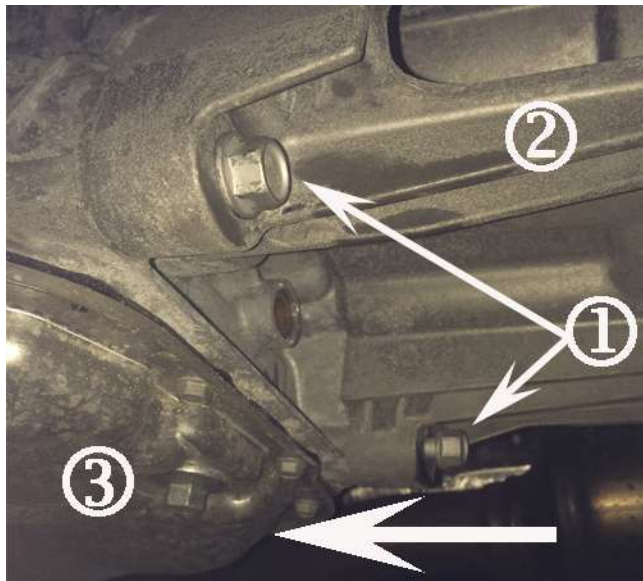
4135343

This bulletin provides a service procedure to install two bolts onto the transfer case adapter housing on **certain** 2015 model year Chevrolet Colorado 4WD and GMC Canyon 4WD vehicles equipped with a 2.5L engine (RPO LCV) and a 6-speed automatic transmission (RPO MYB). These vehicles may be missing two lower transfer case adapter bolts. This could cause increased vibration at vehicle speeds above 80 mph (128 km/h). CAE analysis shows that there will be increased stress levels to the transmission housing, bell housing, and adapter housing. If a vehicle with this condition also has a severely imbalanced driveline and is operated at high vehicle speeds for a long period of time, these increased stress levels could lead to cracks in the transmission housing, bell housing, and adapter housing. If cracks occur, the vehicle could leak transmission fluid. With enough fluid loss, the "Check Engine" light will illuminate. Additionally, if the adapter housing develops a circumferential crack, the vehicle could suddenly lose propulsion.

Note: Confined area calls for a short socket.

Note: The adapter is bolted to the transmission with six fasteners inside the adapter housing. Threading in the two lower external bolts may meet with some resistance. If needed, gradually thread bolts in/out before final torquing to ensure complete seating of fasteners.

2. Install the two transfer case adapter lower bolts (1) through the adapter (2) and into the transmission (3).
3. Torque the bolts to **58 Nm (43 lb-ft)**.
