SUBJECT: Service Update for Inventory and Customer Vehicles - Front Lower Control Arm Rear Link Ball Joint Re-torque – Both Sides
Expires with Base Warranty

MODELS: 2014-2015 Chevrolet Caprice, Caprice PPV, SS

Subject: 15019 – Service Update Bulletin
Front Lower Control Arm Rear Link Ball Joint Re-torque – Both
Sides

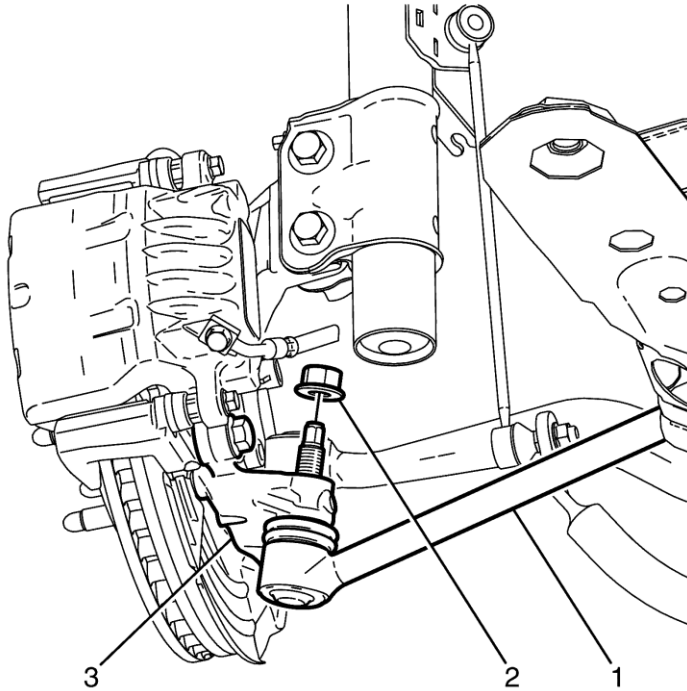
1949920

This bulletin provides a service procedure to re-torque the front lower control arm rear link ball joint nuts on **certain** 2014-2015 model year Chevrolet Caprice and SS vehicles. These vehicles may have under torqued front lower control rear link ball joint nuts. This condition may result in a clunk or rattle type noise in the front suspension.

1. Raise and support the vehicle. Refer to *Lifting and Jacking the Vehicle* in SI.
2. Torque the existing front lower control arm rear link (1) ball joint nut (2) to **150 Nm (111 lb-ft)** to fully seat the joint in the steering knuckle (3).
3. Loosen the ball joint nut (2) 180 degrees.
4. Re-torque the ball joint nut (2) to **55 Nm (41 lb-ft)**.
5. Tighten nut another 30 degrees.
