Service Bulletin

SUBJECT: Service Update for Inventory and Customer Vehicles
Driver's Side Front Roof Ditch Molding Water Leak
Expires with Base Warranty

MODELS: 2015 Cadillac Escalade
2015 Chevrolet Tahoe
2015 GMC Yukon

Subject: 15183 – Service Update Bulletin
Driver's Side Front Roof Ditch Molding Water Leak

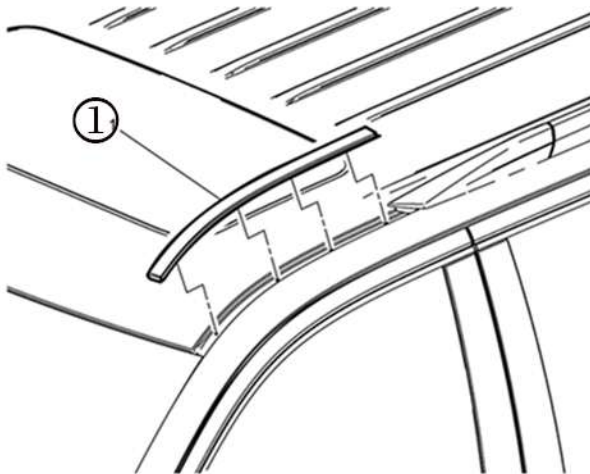
4110110

Note: Due to the likelihood of the retaining clips being damaged during molding removal, replacement of the finish molding is recommended.

1. Remove the left roof panel joint finish molding (1). Refer to *Roof Panel Joint Finish Molding Replacement* in SI.

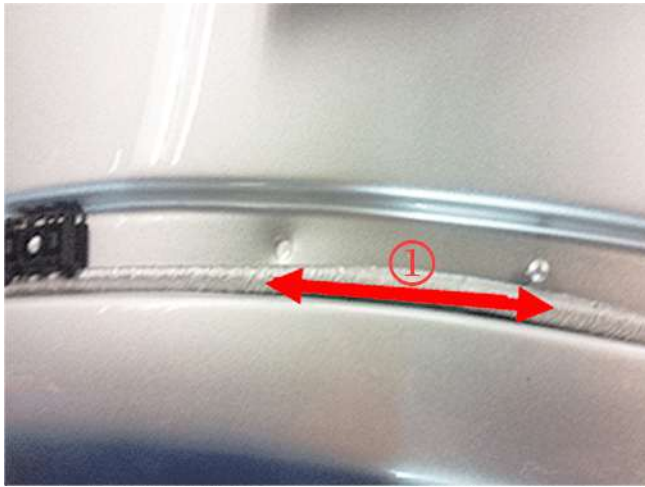
4110114

2. In the area between the forward roof weld and the second roof stud (1), inspect for voids/gaps in the seam sealer **along the outboard edge** of the roof ditch.
