SERVICE BULLETIN

APPLICABILITY: 2012-13MY Impreza 2.0L Models
 2013MY XV Crosstrek
 2014-15MY Forester

NUMBER: 12-157-13R

SUBJECT: Rattle or Buzzing Sound from “A” Pillar Trim

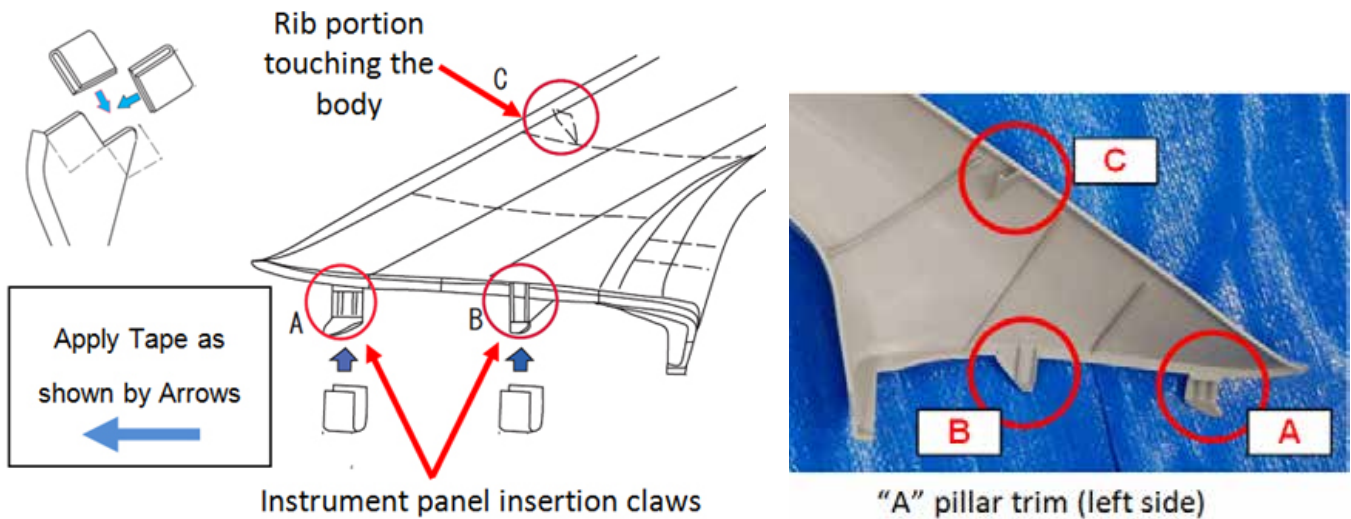
This bulletin provides a repair procedure to address a customer concern of a rattle or buzzing-type sound coming from the lower portion of the “A” pillar trim while driving over bumpy or rough road surfaces. The lower insertion claws and / or the trim’s support rib may be coming in contact with the vehicle body causing the sound.

- With the “A” pillar trim at room temperature, clean the 3 areas shown in the illustration below (A, B, and C) with rubbing alcohol applied to a clean shop cloth then allow to dry before installing the non-woven material.

NOTE: Any reference relating to Rib portion “C” is not applicable to Forester models.
