## SERVICE BULLETIN

**APPLICABILITY:** 2015MY Legacy and Outback Models

**NUMBER:** 12-177-14R

**SUBJECT:** Service Procedure to Address a Wind Rushing Sound from the Rear Door Sash Area

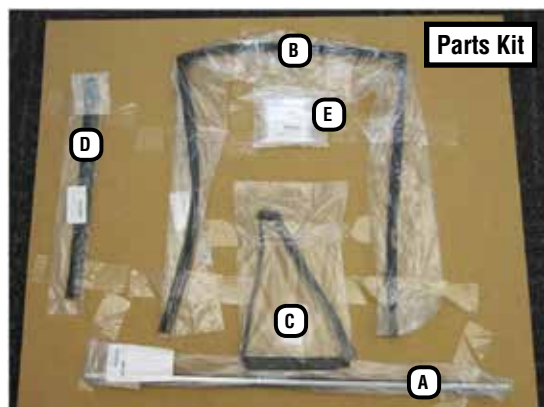
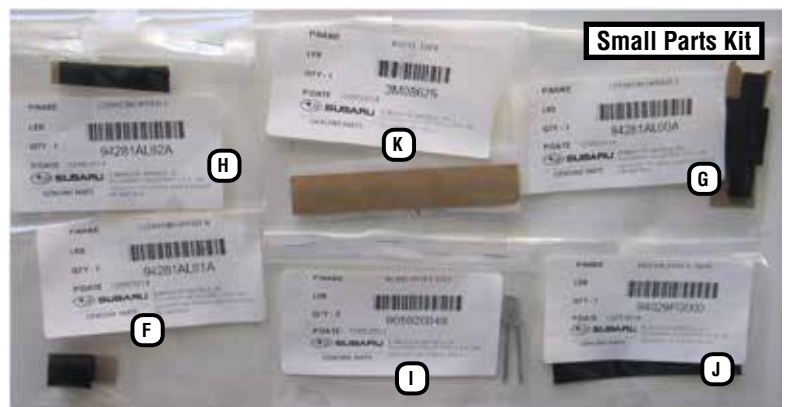
**NOTE:** If you have in stock or receive a repair kit with an 80mm section of butyl tape included (item “K” in the photo below), a much longer, (320mm) section, p.n. **SOA635138** must be ordered to properly complete these repairs. All repair kits with a Pack Date after May 1st, 2015 will include the longer 320mm section of butyl tape. The repair kit part numbers will remain unchanged.
