SERVICE BULLETIN

APPLICABILITY: 2015MY Legacy and Outback Models
SUBJECT: Wind “Rushing” or “Fluttering” Sound from
“B” Pillar Area

NUMBER: 12-185-15
DATE: 05/21/15

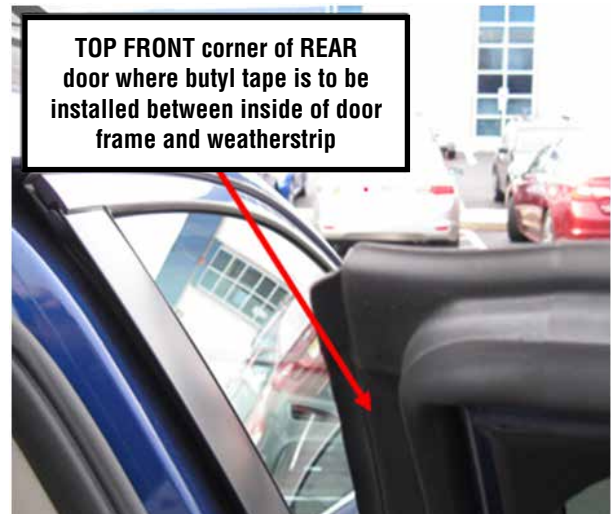
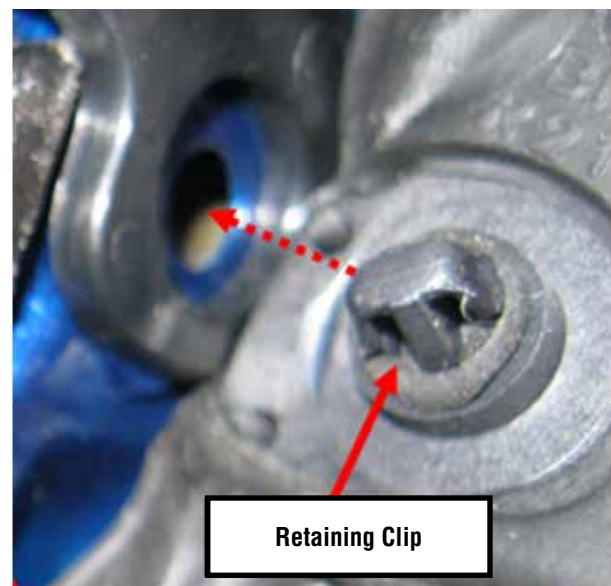
Road test vehicle to verify the sound is coming from “B” pillar area. Once confirmed, verify which side, left, right or both and continue with repair procedure.

Use a plastic trim tool to release the plastic retaining clip located at the top front corner of the door. **CAREFULLY** pull back the weatherstrip to gain access to the area where the butyl tape will be applied.
