SERVICE INFORMATION

APPLICABILITY: 2008-09 and Early-Production 2010MY Impreza, WRX and STI Models with Manual Transmission **NUMBER:** 12-184-15
SUBJECT: Creak / Popping-Type Sound from Clutch Pedal Bracket Welds **DATE:** 05/28/15

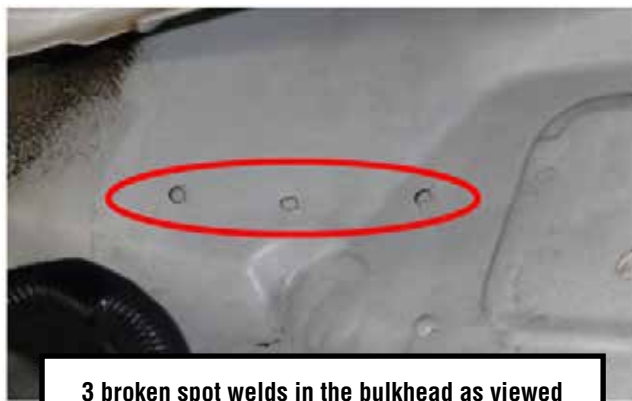
3 broken spot welds in the bulkhead as viewed from the engine compartment side of the cowl

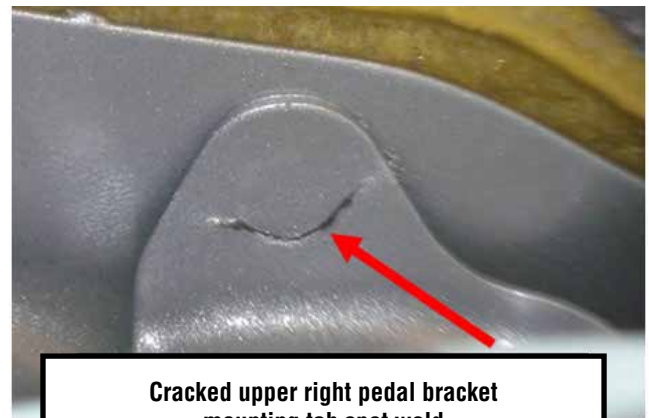
Cracked upper right pedal bracket mounting tab spot weld

The thickness of the pedal bracket was changed from 1.0mm to 1.4mm and one additional weld was added in production on August 17, 2009 starting with the following VINs:

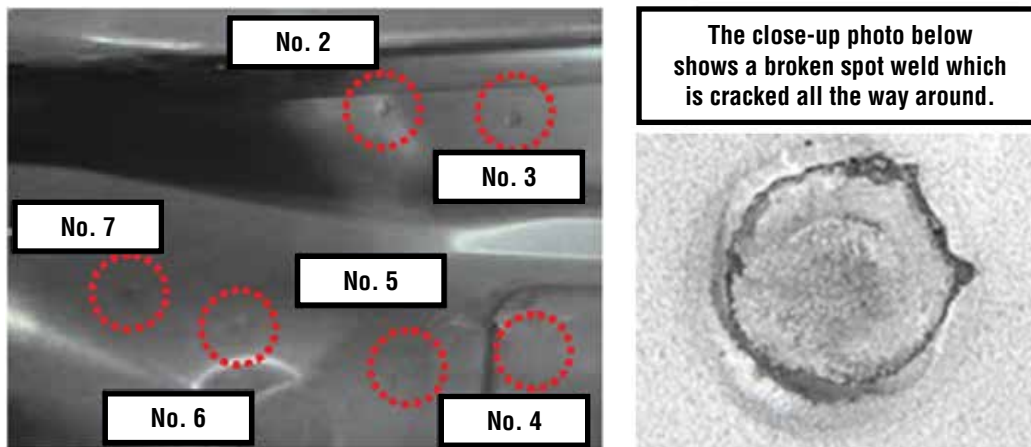
- If any spot welds or surrounding metal visible from the cowl area on the engine compartment side are cracked or broken, welding repairs will be needed. Regardless if weld damage is found or not, proceed to **Step 3**.

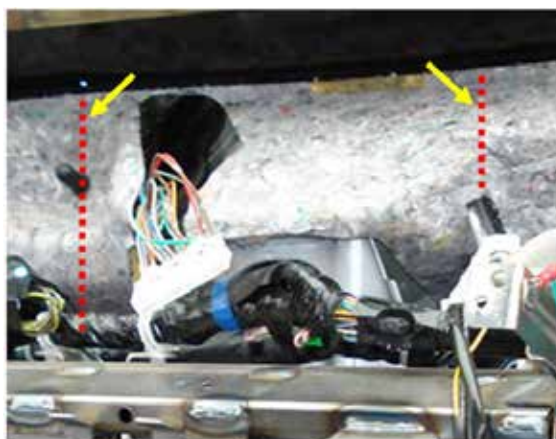
If any of the pedal bracket spot welds, the bracket itself or the surrounding metal is confirmed to be cracked or broken, welding repairs will be necessary. If no visible weld damage is found, operate the clutch and / or brake pedal additional times to confirm the source of the sound or feeling is not coming from the bracket or its spot welds.

If the sound or feeling is coming from the bracket or its spot welds, proceed with welding repairs to reinforce the bracket.
