SERVICE BULLETIN

APPLICABILITY: 2015MY Legacy and Outback Models

SUBJECT: Service Procedure to Address a Wind Rushing

NUMBER: 12-176-14R

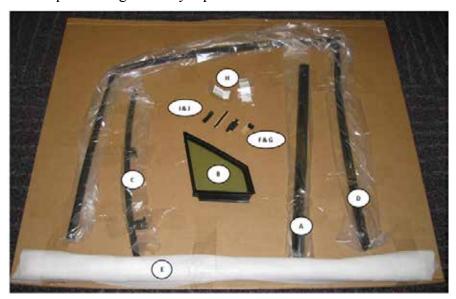
NOTE: If you have in stock or receive a repair kit with an 80mm section of butyl tape included (item "J" in the photo below), a much longer, (**320mm**) section, p.n. **SOA635138** must be ordered to properly complete these repairs. All repair kits with a Pack Date after May 1st, 2015 will include the longer **320mm section** of butyl tape. The repair kit part numbers will remain unchanged.
