SERVICE BULLETIN

APPLICABILITY: 2012-2013MY Impreza with FB Engine **NUMBER:** 02-130-12R
SUBJECT: Oil Seepage Diagnosis and Repair Procedures **DATE:** 07/18/12
REVISED: 03/10/15

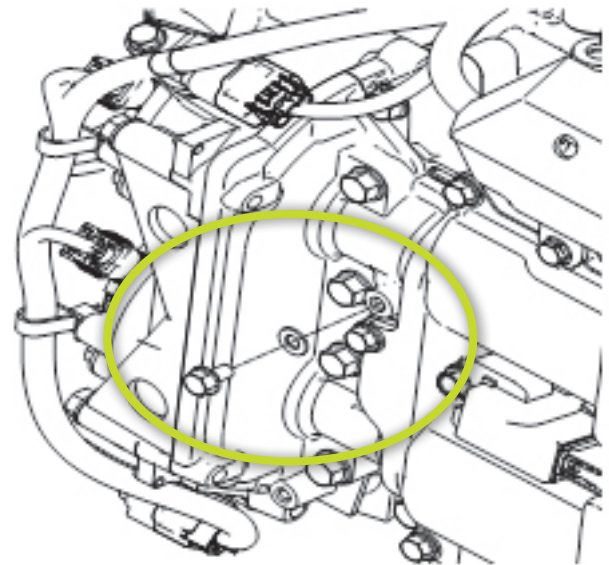
If oil seepage is verified coming from the 6mm threaded hole in the left-hand camshaft cap, install the specified bolt and flat washer.

Bolt: Part# 800206180

Washer: Part# 031106000

Tightening Torque: 6.4 +/- 0.5 Nm
(57 +/- 4 inch-pounds)

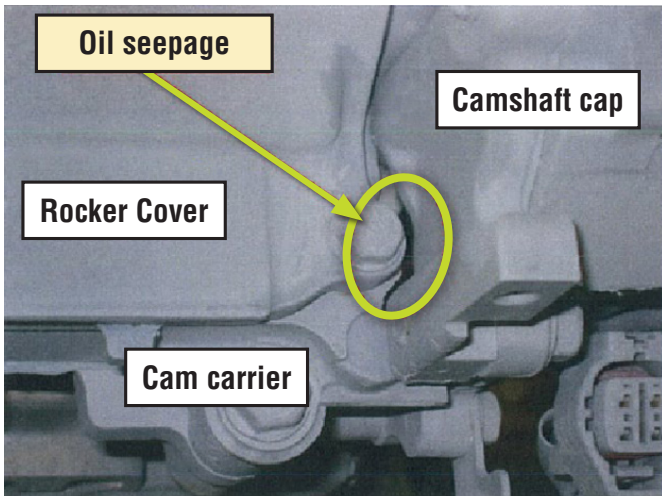
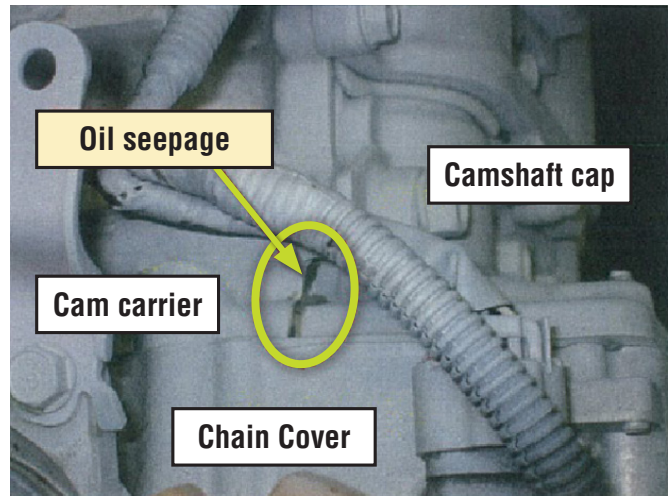
If oil seepage is verified coming from the front camshaft cap or cam carrier as shown in the photos below, remove the cam cap and clean both surfaces thoroughly before applying sealer. **Note:** The 2 o-rings between the camshaft cap and the cam carrier will need to be replaced as they are not re-usable.

Apply Liquid Gasket, ThreeBond 1280B, (Part No. SOA5499100) or equivalent* as shown below:

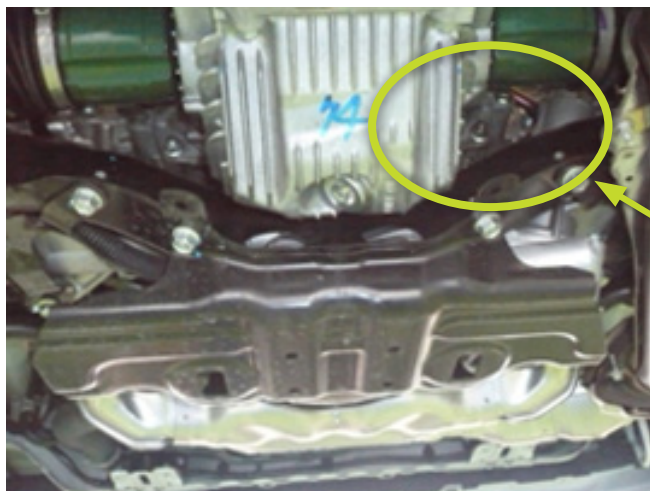
If you find engine oil seepage between the cylinder block and upper oil pan, remove the upper oil pan, clean the machined sealing surfaces thoroughly and then re-seal using Liquid Gasket ThreeBond 1280B, (Part No. SOA5499100) or equivalent*. **Note:** The o-rings between the upper oil pan and the cylinder block along with those between the upper and lower oil pan will need to be replaced as they are not re-usable.

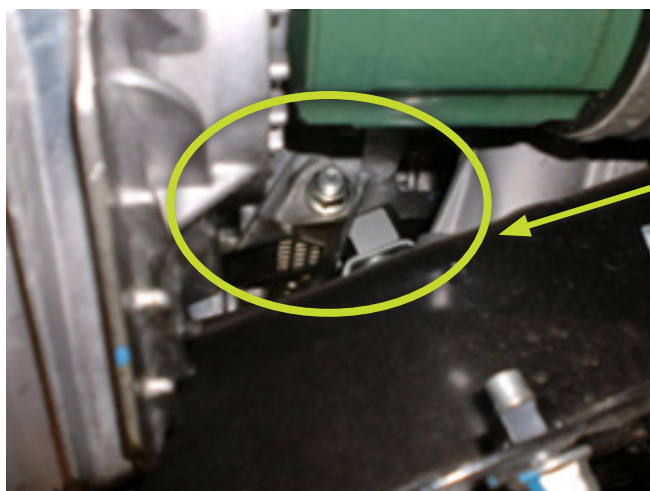
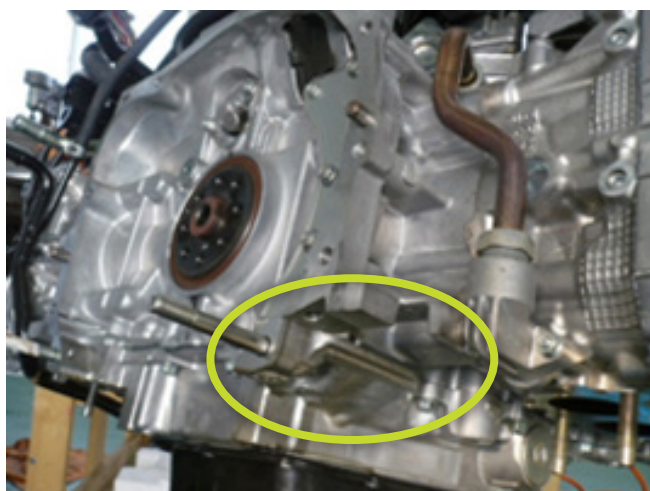
As viewed from the rear, oil seepage from the upper pan to engine block sealing area may be present in these areas.

Photo shows seepage from upper oil pan to engine block sealing surfaces.

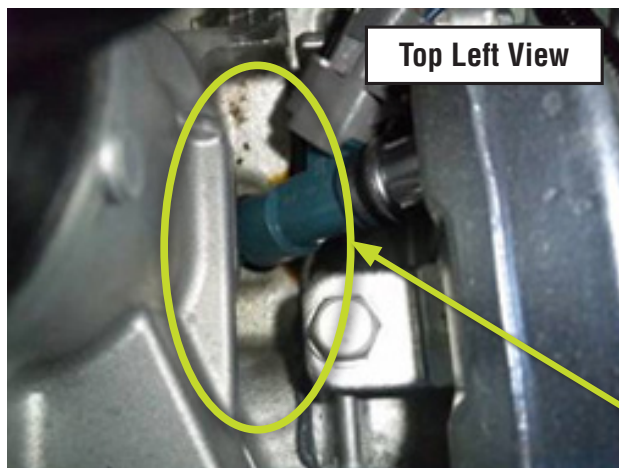
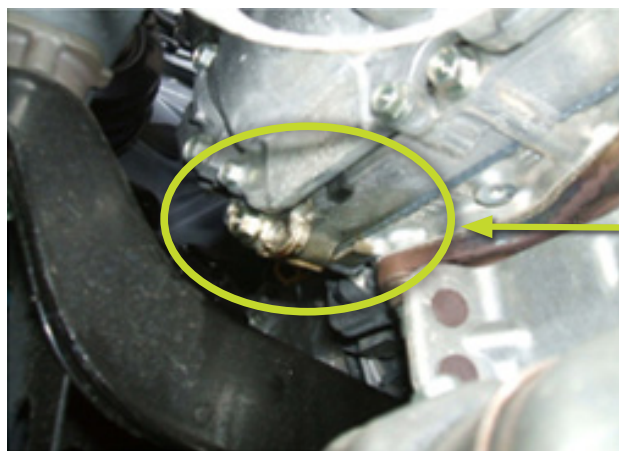
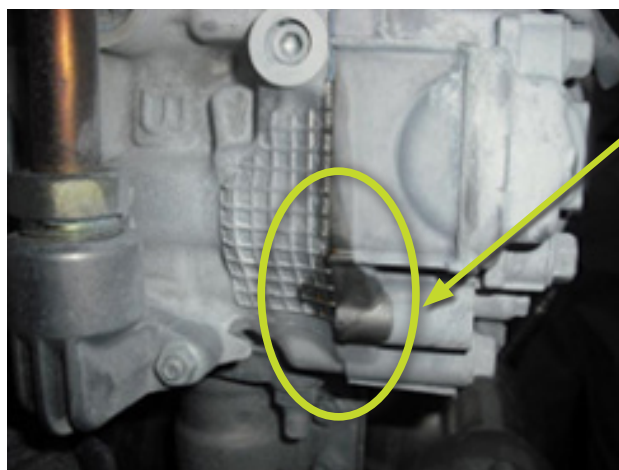
Cam carrier seepage seen from top left and lower right side of engine

If oil seepage is verified coming from between the cam carrier and the cylinder head as shown in the photos below, remove the cam carrier. Clean the machined sealing surfaces thoroughly and then re-seal using Liquid Gasket ThreeBond 1280B, (Part No. SOA5499100) or equivalent*. As shown in the photos below, the o-rings between the cam carrier and the cylinder head will need to be replaced as they are not re-usable. This would also be a good time to clean the Active Valve Control System (AVCS) filter screens which are contained in the cam carriers. **NOTE:** The filter screens are one-time use and must be replaced if they need to be removed. The replacement filter part# is 14451AA050.

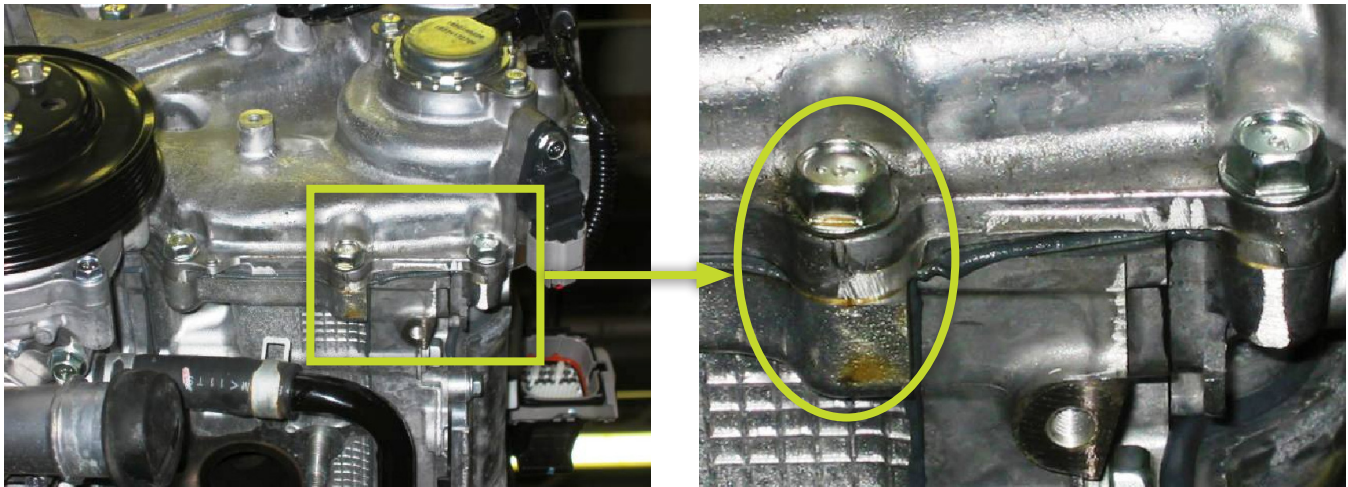
Note: Only reseal the front chain cover AFTER confirming there is no oil seepage coming from the cam retainer cap (area 1) as previously described.

1. If there are no oil droplets found on the engine under-cover or the lower radiator hose, thoroughly clean the chain cover sealing area along with the surrounding cylinder head and crankcase areas. Re-check for oil seepage again at the next service interval.
2. If the front chain cover is leaking and needs to be resealed, follow the repair procedure in the applicable Service Manual. Thoroughly clean and inspect the sealing surfaces then re-seal using Liquid Gasket ThreeBond 1280B, (Part No. SOA5499100) or equivalent*.
