SUBARU

SERVICE BULLETIN

APPLICABILITY: 2011-2014MY Forester Models with FB Engine

SUBJECT: Oil Seepage Diagnosis and Repair Procedures

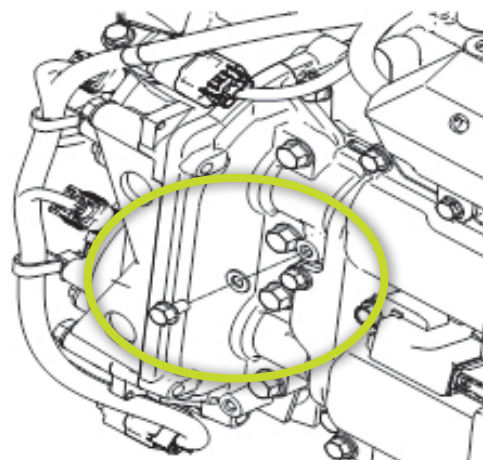
If oil seepage is verified coming from the 6mm threaded hole in the left-hand camshaft cap, install the specified bolt and flat washer.

Bolt: Part# 800206180

Washer: Part# 031106000

Tightening Torque: 6.4 +/- 0.5 Nm
 (57 +/- 4 inch-pounds)

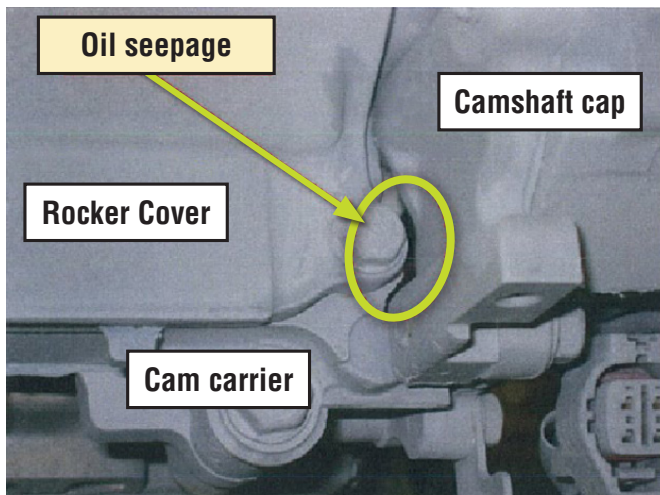
If oil seepage is verified coming from the front camshaft cap or cam carrier as shown in the photos below, remove the cam cap and clean both surfaces thoroughly before applying sealer. **Note:** The 2 o-rings between the camshaft cap and the cam carrier will need to be replaced as they are not re-usable.

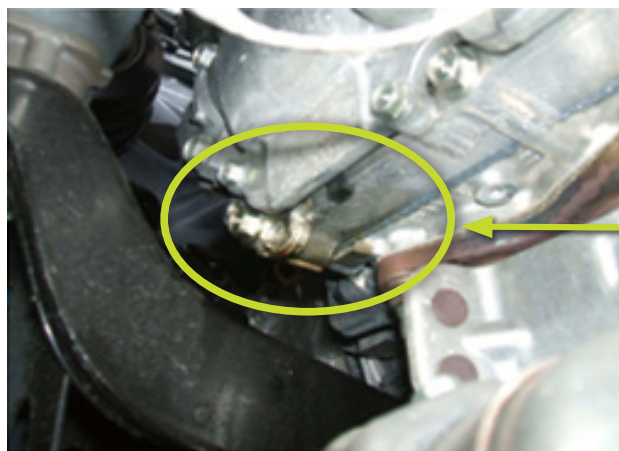
If oil seepage is verified coming from between the cam carrier and the cylinder head as shown in the photos below, remove the cam carrier. Clean the machined sealing surfaces thoroughly and then re-seal using Liquid Gasket ThreeBond 1280B, (Part No. SOA5499100) or equivalent*. As shown in the photos below, the o-rings between the cam carrier and the cylinder head will need to be replaced as they are not re-usable. This would also be a good time to clean the Active Valve Control System (AVCS) filter screens which are contained in the cam carriers. **NOTE:** The filter screens are one-time use and must be replaced if they need to be removed. The replacement filter part# is 14451AA050.

Cam carrier seepage seen from top left and lower right side of engine

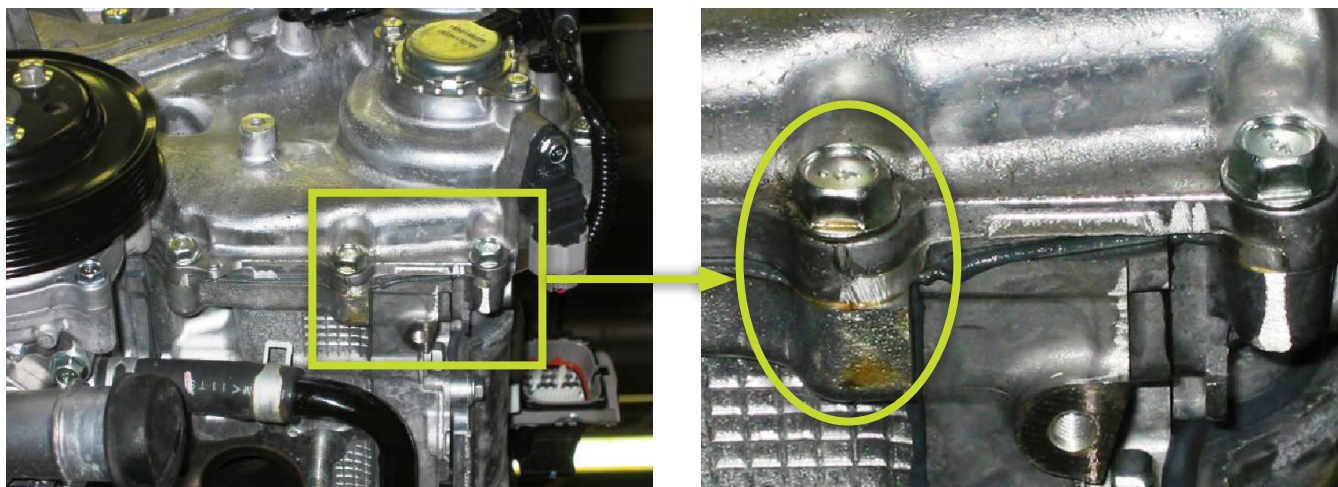
Note: Only reseal the front chain cover AFTER confirming there is no oil seepage coming from the cam retainer cap (area 1) as previously described.

1. If there are no oil droplets found on the engine under-cover or the lower radiator hose, thoroughly clean the chain cover sealing area along with the surrounding cylinder head and crankcase areas. Re-check for oil seepage again at the next service interval.
2. If the front chain cover is leaking and needs to be resealed, follow the repair procedure in the applicable Service Manual. Thoroughly clean and inspect the sealing surfaces then re-seal using Liquid Gasket ThreeBond 1280B, (Part No. SOA5499100) or equivalent*.
