SERVICE BULLETIN

APPLICABILITY: 2015 Legacy and Outback Models with Fujitsu-Ten (F10) Navigation System **NUMBER:** 15-180-15
DATE: 03-31-15
SUBJECT: Erroneous Time Zone Setting Affecting Clock Time Accuracy and Estimated Arrival Times

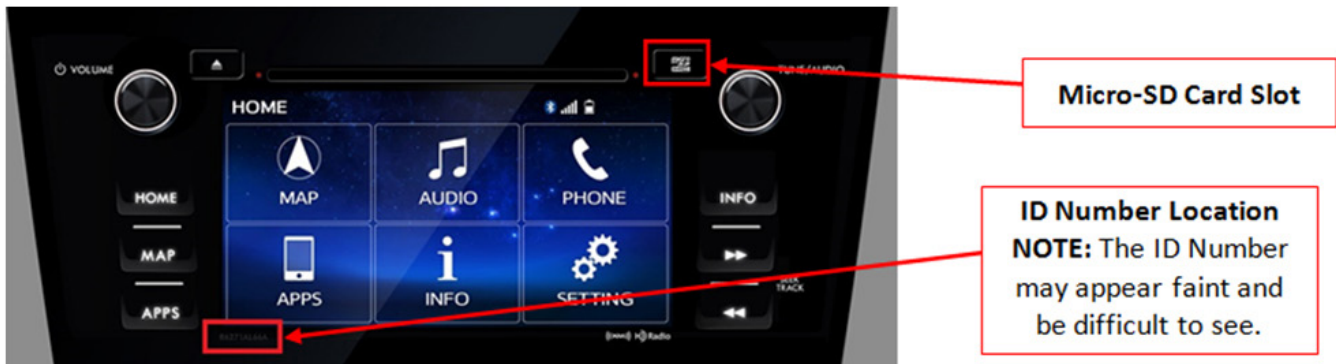
Micro-SD Card Slot

ID Number Location
NOTE: The ID Number may appear faint and be difficult to see.

With the Audio / Navigation system and the ignition **OFF**, **CAREFULLY** open the small Micro-SD card slot cover with your finger nail and eject the card.

- Inspect the removed Micro-SD card.
 - If the part number is **86283AL66A** and it **has** a white dot on the label, or is part number **86283AL66B**, reinstall the card as no further action is required. This bulletin does not apply. Refer to the applicable Service Manual and the applicable audio/ navigation Troubleshooting Guide on STIS to determine the cause of any clock concern.
 - If the part number is **86283AL66A** and there is **no** white dot on the label, install either a new **86283AL66A** card with a white dot or, a new **86283AL66B** card. Please note that the **86283AL66B** card has no white dot.
- Close the card slot cover, turn on the ignition and the Audio / Navigation system then press the **MAP** button to confirm the map screen displays normally to complete the repair.
