## SERVICE BULLETIN

**APPLICABILITY:** 2015MY Legacy, Outback, Impreza, XV Crosstrek and WRX Models with Fujitsu-Ten (F10) 7” Display Audio Systems (without navigation) **NUMBER:** 15-183-15R  
**DATE:** 06/17/15  
**REvised:** 07/20/15

**SUBJECT:** Procedures for Updating the Head Unit Operating Software

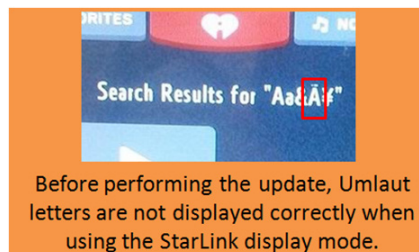
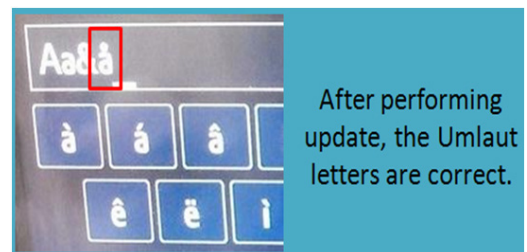
- **Symptom 1:** Audio output is lost after a few minutes when listening to Sirius/XM satellite radio.  
**Change:** Logic update to provide proper Sirius/XM satellite radio operation.
- **Symptom 2:** Bluetooth feature becomes inoperative.  
**Change:** Logic update to provide proper Bluetooth feature operation.
- **Symptom 3:** HD Radio “freezes” after a few minutes of play.  
**Change:** Logic update to provide proper Sirius/XM satellite radio operation.
- **Symptom 4:** Back-Up Camera “help lines” do not appear.  
**Change:** Logic change to have the assist lines appear 8 seconds from engine start.
- **Symptom 5:** Incorrect Umlaut characters are shown on StarLink display.  
**Change:** Logic change to allow proper display of Umlaut letters.

List of incorrect Umlaut letters is shown in yellow.

After performing update, the Umlaut letters are correct.

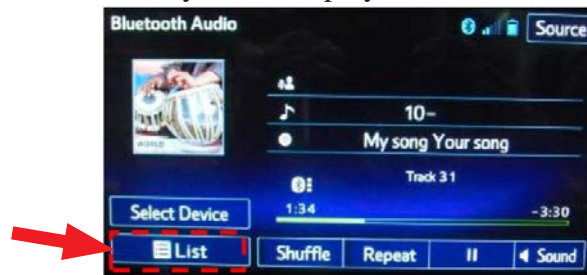
- **Symptom 9:** “LIST” soft touch key is not displayed on Bluetooth Audio screen while using

Bluetooth audio feature with an Apple device utilizing iOS8 software version.

**Change:** Logic change to enhance compatibility with iOS8 software.

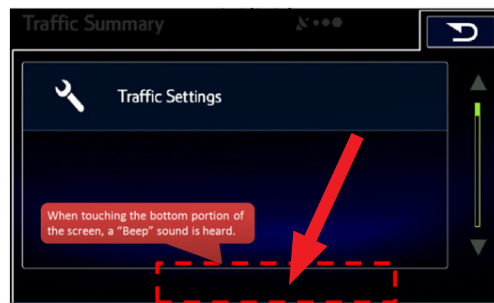
- **Symptom 10:** “Beep” sound heard when touching the bottom of the display screen where no function soft touch keys are displayed.

**Change:** Logic change to eliminate beeping sound from inactive soft touch key screen areas.

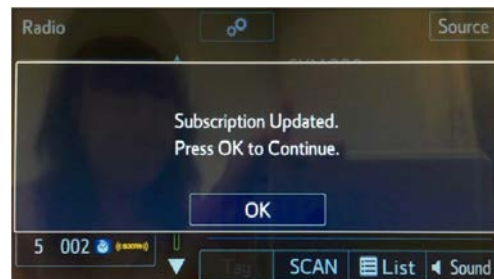
- **Symptom 11:** Sirius/XM caution message screen is displayed in English even when French language operation settings are selected.

**Change:** Logic change to make all messages display in the selected operating language.

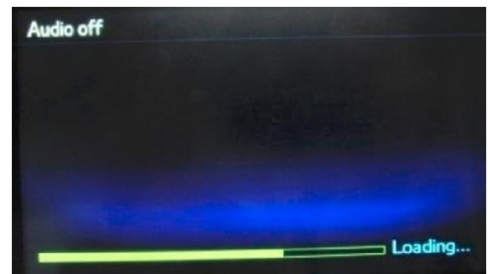
Loading Screen

- **Symptoms 12-16:** The following symptoms are all related to the inability of the software to properly load. One or all of these 5 conditions may occur at the same time. Logic changes have been included in the applicable update to address each of the following conditions:

- Repeated display of the “Loading” screen at initial unit start-up
- Bluetooth device pairing failure
- Inoperative steering wheel (satellite) switches
- Voice recognition feature inoperative
- Sirius/XM radio feature inoperative.
