SERVICE BULLETIN

APPLICABILITY: 2013MY BRZ

NUMBER: 07-94-15

SUBJECT: Interference between the Fender and Side Marker Lamp

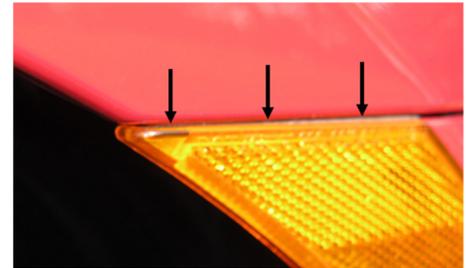
This bulletin provides a repair procedure to address concerns of contact between the top horizontal edge of the side marker lamp and the corresponding fender edge as shown in the photo to the right.
