MODEL  
2011~2013MY  
Sorento (XMa)

NUMBER  
093 (REV 5, 06/19/2015)

## TECHNICAL SERVICE BULLETIN

SUBJECT: SECOND ROW SEAT INOPERATIVE OR DIFFICULT TO RELEASE

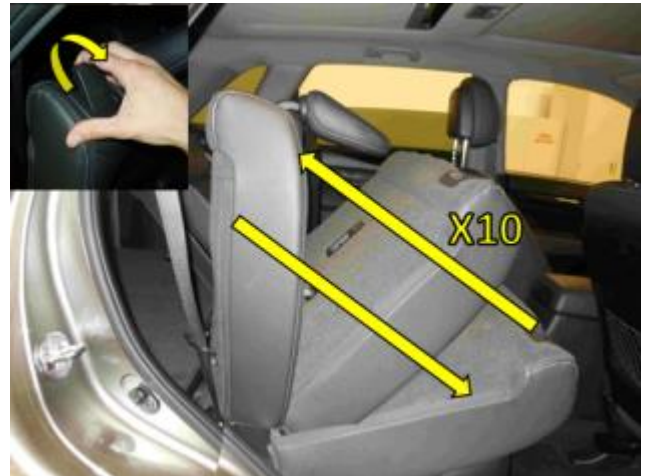
1. Lift recliner release handle and function seat in all positions (10 times). If the seat recliner operates correctly, no further action is required.

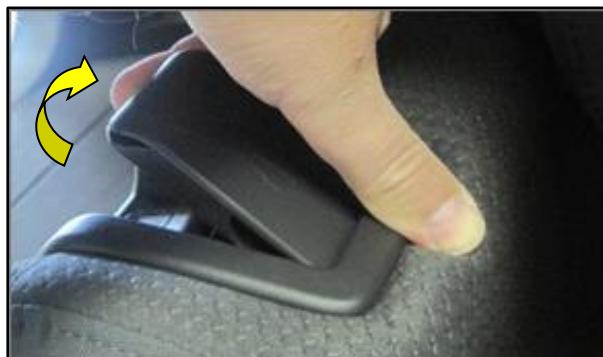
1. Operate the seatback reclining handle to verify excessive effort is required.

You may need to apply pressure to the seatback in order to free a jammed recliner mechanism.

Verify excessive effort required to operate handle.
