MODEL
2016MY
Sorento (UMa)

NUMBER
PS411

SUBJECT: POWER TAIL GATE FUNCTIONALITY CONCERNS

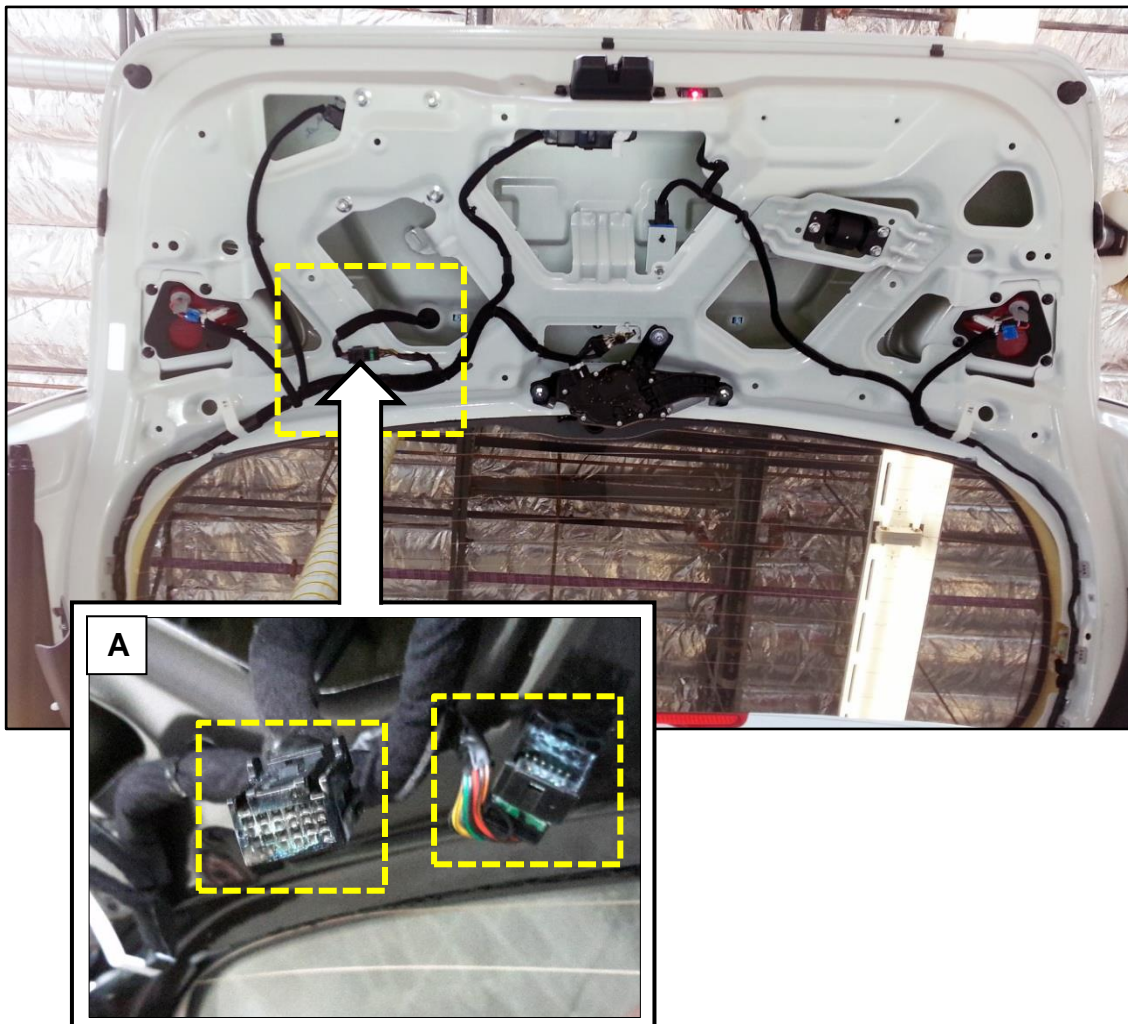
When diagnosing a concern related to Power Tail Gate (PTG) functionality on 2016MY Sorento (UMa) vehicles, produced prior to January 13, 2015, closely inspect connector RR01 for evidence of corrosion. This connector can be accessed by removing the interior tail gate trim, as outlined in Body > Interior-Exterior section of KGIS. If corrosion is found in the connector (A), the tailgate and exterior garnish-side harness must be replaced – Refer to EPC for applicable part numbers.
